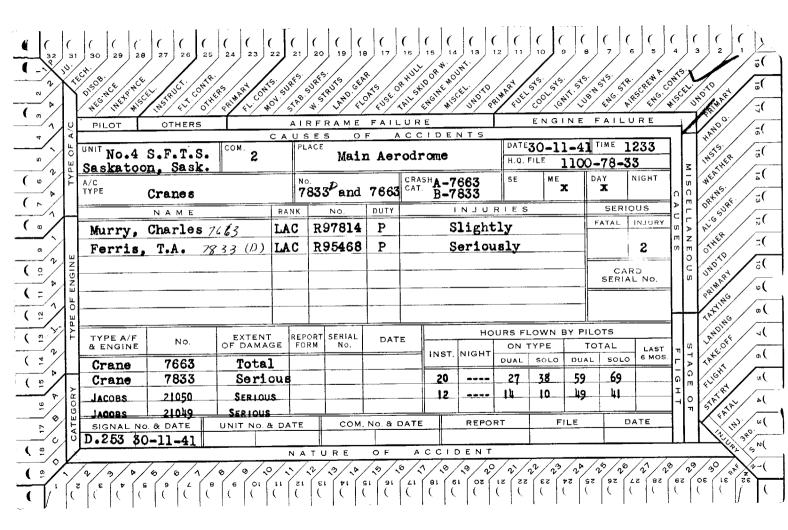
DUTY ON WHICH ENGAGED: Both aircraft solo circuits. MATURE OF ACCIDENT AND STAGE OF FLIGHT: 7833 landed on top of 7663 about 25 feet in the air as both aircraft were levelling out for a landing on east end of east- west runway. PRIMARY CAUSE: Pilot of aircraft 7633 failed to observe aircraft 7663 underneath him as bothwere approaching and pilot of 7833 made a normal approach. Investigations being carried out under arrangements. ACCION TAKEN: (A) DISCIPLINARY (B) TECHNICAL (C) OTHER RECONDARY CAUSE OR CONTRIBUTING FACTORS: Aircraft collided just after landing. AIRCRAFT 7833 COLLIDED WITH 7665.	j	· · · · · · · · · · · · · · · · · · ·)))))))	$\rightarrow \rightarrow \rightarrow \rightarrow$
7833 landed on top of 7663 about 25 feet in the air as both air- craft were levelling out for a landing on east end of east- west runway. PRIMARY CAUSE: Pilot of aircraft 7833 failed to observe aircraft 7663 underneath him as bothwere approaching and pilot of 7833 made a normal ap- proach. Investigations being carried out under arrangements. ACTION TAKEN: (A) DISCIPLINARY (B) TECHNICAL (C) OTHER SECONDARY CAUSE OR CONTRIBUTING FACTORS: Aircraft collided just after landing. AIRCRAFT 7835 COLLIDED MITH 7663.))			CER)

landing on east end of east- west runway. PRIMARY CAUSE: Pilot of aircraft 7833 failed to observe aircraft 7663 underneath him as bothwere approaching and pilot of 7833 made a normal approach. Investigations being carried out under arrangements. ACTION TAKEN: (A) DISCIPLINARY (B) TECHNICAL (C) OTHER SECONDARY CAUSE OR CONTRIBUTING FACTORS: Aircraft collided just after landing. AIRCRAFT 7833 COLLIDED WITH 7663.)	7833 landed on top of 7663 about)
Pilot of aircraft 7833 failed to observe aircraft 7663 underneath him as bothwere approaching and pilot of 7833 made a normal approach. Investigations being carried out under arrangements. Secondary cause or contributing factors: Aircraft collided just after landing. Recorded by Date Aircraft 7833 collided with 7663. Checked by Date)	craft were levelling out for a landing on east end of east-west runway.		PX 74)
Aircraft collided just after landing. AIRCRAFT 7833 COLLIDED WITH 7663. CHECKED BY DATE		Pilot of aircraft 7833 failed to observe aircraft 7663 underneath him as bothwere approaching and pilot of 7833 made a normal approach. Investigations being	ACTION TAKEN: (A) DISCIPLINARY (B) TECHNICAL (C) OTHER	1ER

))))	Aircraft collided just after landing.		_	
	ラ ト			CHECKED BY	DATE)
