Aircraft Accident Summary
Résumé d'accident d'aéronef

TYPE: CH11305 Labrador

DATE: 02 October 98

**LOCATION: 3 NM South of
Marsoui QC.**

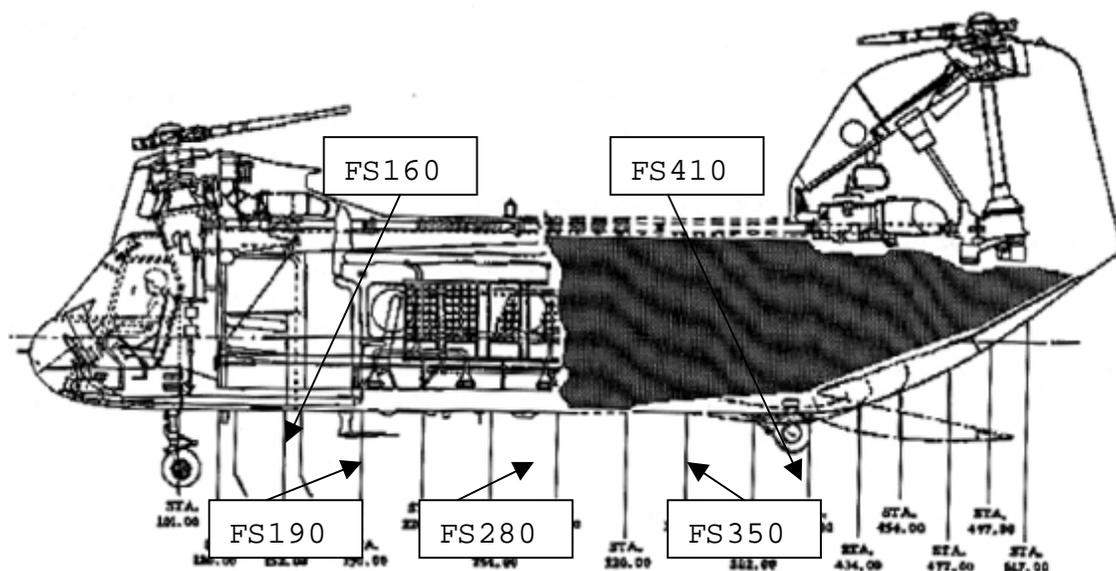
Figure 1: Flight Stations and Area Consumed by Post-crash Fire

Reconstruction of the aircraft in Ottawa revealed that the destructive forces of the accident had consumed a large section of the rear of the aircraft. None of the structure of the aircraft aft of FS 280 and above the floor remained, except the stainless steel engine compartments at FS410 and much of the rear ramp area which was scorched both inside and out. Some of the stub wing fuel tank structures and landing gear supports survived these destructive forces and the entire rear pylon and rotor head, located above the steel engine boxes, displayed little fire damage.

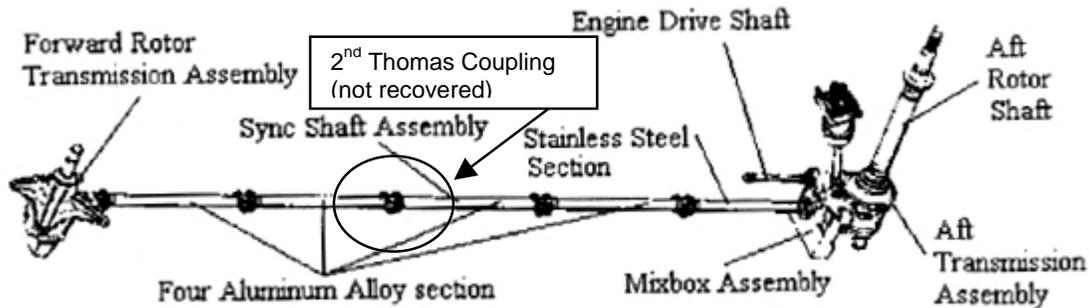
Figure 2: Sync Shaft and Transmission Assemblies

still attached (Photo 29). This damage pattern suggested these sections of the sync shaft were melted in the post crash fire.

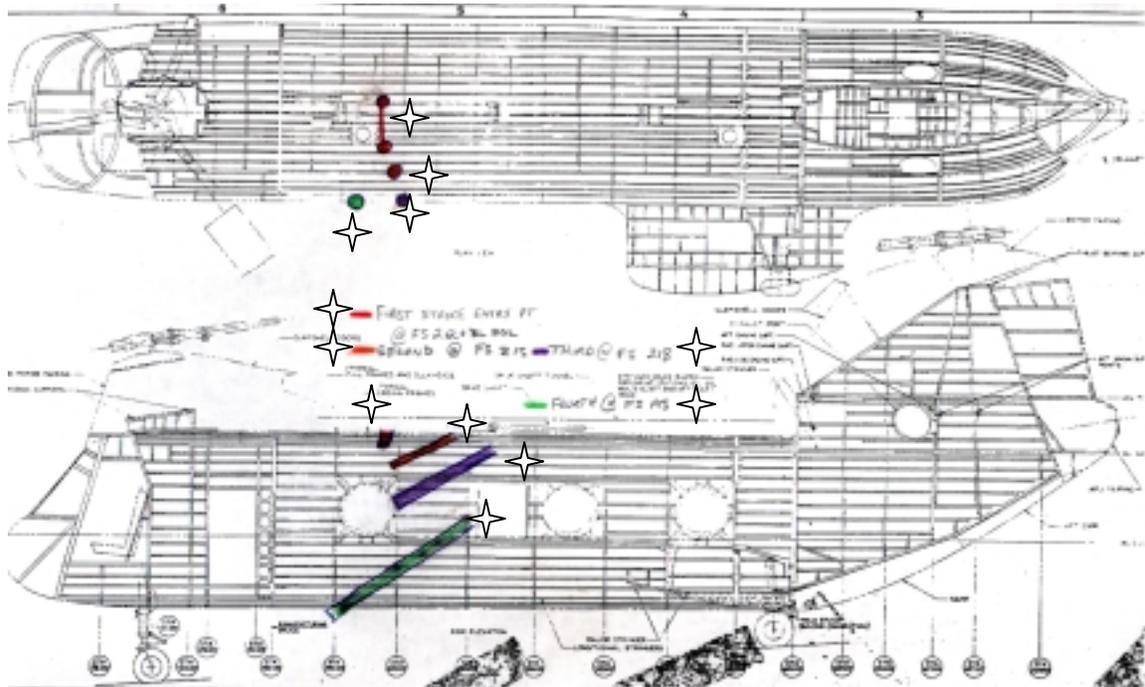
Figure 3: Blade Strike Entry Points and Damage Paths

Base Line (BL) 20 Left(L))that tore off a piece of sync shaft tunnel cover, severed the upper fuselage, cut the sync shaft and the control cables. The piece of tunnel cover from this uppermost blade strike was found at the top of the mountain in the debris field. Much of the tunnel cover was recovered and reconstruction showed that soot had been deposited on the inside right of the cover with more significant levels of soot towards the rear. The piece of tunnel cover removed by the first blade strike showed soot had been deposited before the blade contact propelled it from the aircraft. This indicates that a fire producing soot pre-existed the blade to fuselage contact.

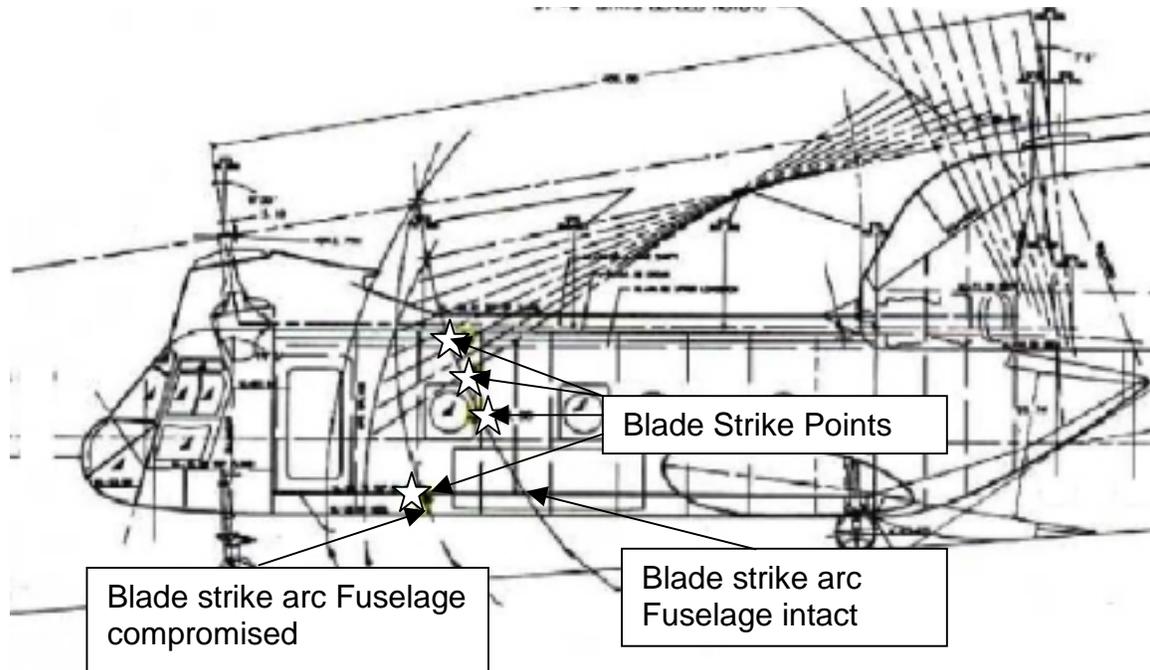
Figure 4: Pylon position and blade arcs compared to fuselage strike positions

The rear pylon and rotor head were found separated from the rest of the aircraft with the blades attached. The mapping of the fuselage cut locations indicated that the first three cuts were made while the rear pylon and aircraft fuselage were in their normal configuration and position. From this evidence, it is concluded the blade to fuselage cut up sequence was initiated with the aircraft fuselage intact. Therefore, the fuselage did not buckle so no substantial deformation to the aircraft had occurred until after the blade to fuselage cutting sequence began and serious fuselage deformation commenced between the third and fourth blade to fuselage cuts.

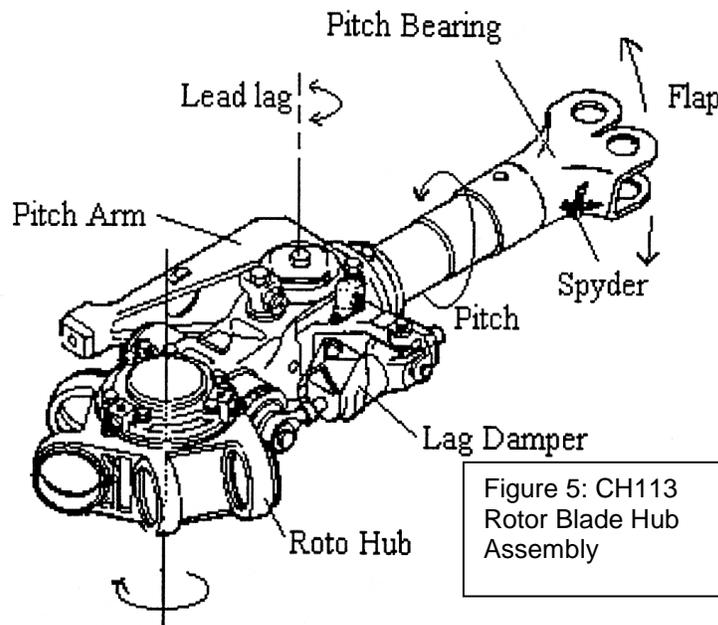
The two rotor heads were recovered and mounted in jigs in the re-build facility. The damage sustained by the forward head was completely different from that sustained by the aft head. The forward head dampers were in three different extension positions. One in full lead (fully extended), another in full lag (no extension) and the third was partially extended. This is consistent with a rotor head impacting the ground in a state of rotation. The rest of the damage to the front head is consistent with ground impact and evidence found at the accident scene supports this determination.

The lack of rotational damage to the surrounding forest and ground is evidence that the aft rotor impacted the ground after rotation had essentially stopped. This is corroborated by damage patterns observed on the many components of the rear rotor that are consistent with ground impact and no rotation. However, some the rear head control linkages displayed symmetrical damage consistent with large forces applied while the head was rotating, particularly the damage to blade (lag) dampers and pitch horns (arms)(Photo 30). All the dampers were found failed in the fully extended position indicating excessive lead motion. Similarly, the pitch horns were failed in a manner indicating blade lead beyond the structural limits of the dampers, resulting in pitch horn contact with the horizontal hinge caps. All of the up and down droop stop surfaces display evidence of contact. Therefore, the damage on the rear rotor head has two distinct patterns, one due to impact with the ground but the other pattern appears to have occurred with the head rotating. It is thus assessed that the rear rotor experienced an in-flight event that caused severe

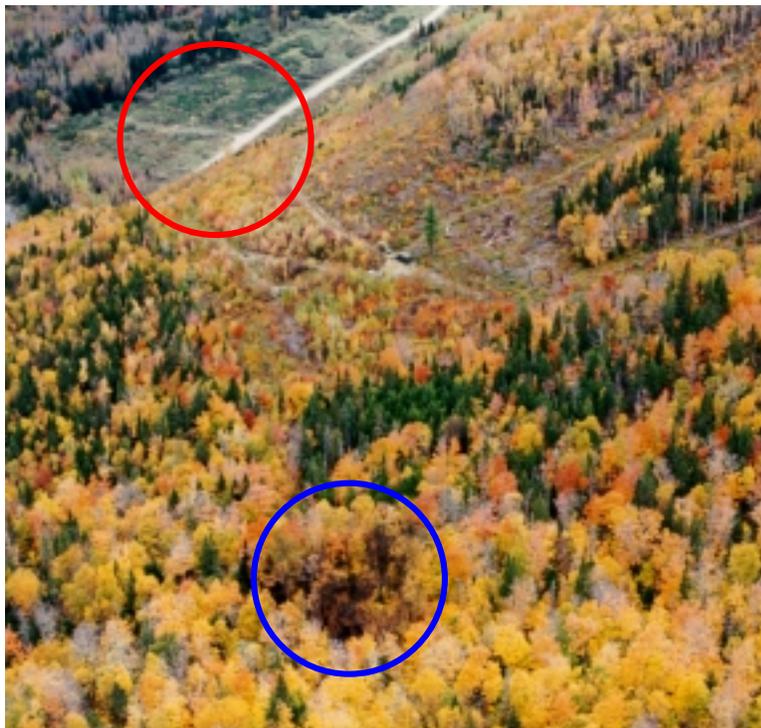
Photo 4- Emergency Landing Zone (Red) and Site 3 - Rear Fuselage Burn Mark (Blue) (Note truck at Upper Recovery Location)// Zone d'atterrissage d'urgence (en rouge) et secteur 3 : preuves de la combustion du fuselage arrière (en bleu) (remarquez le camion dans le secteur supérieur de récupération)

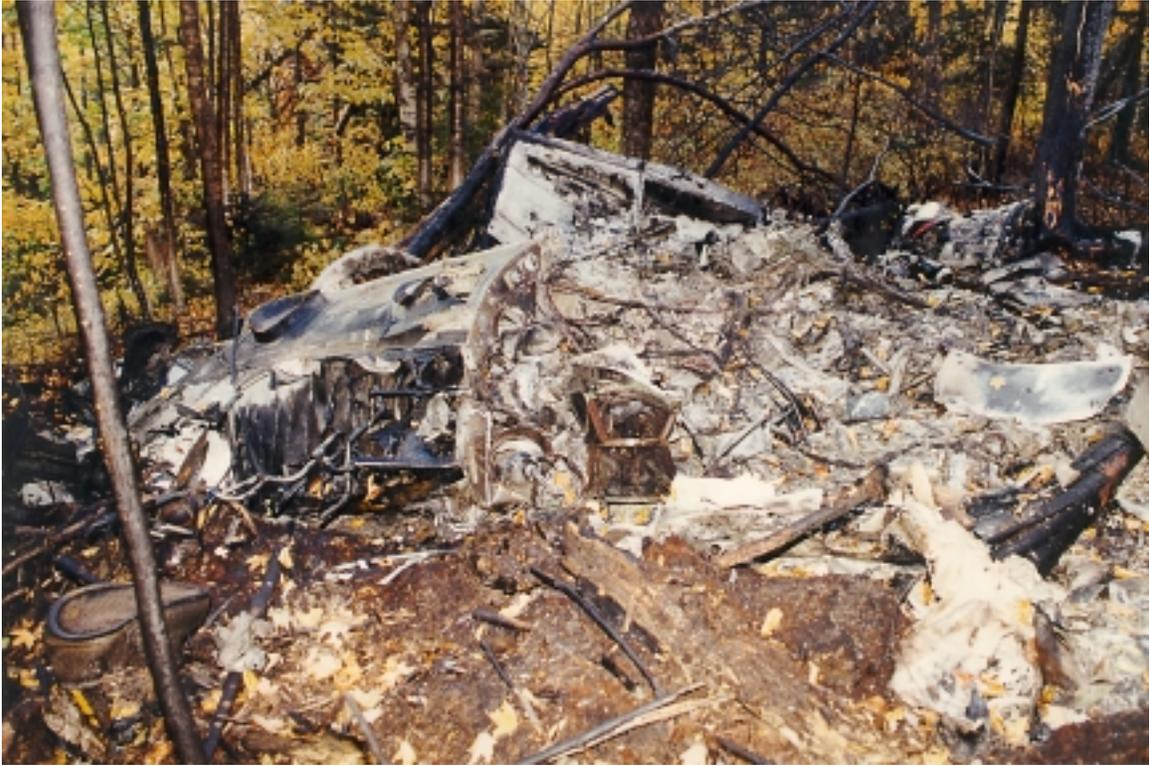
Photo 5 - Site 3 - Aft Fuselage, Engines and MGB// Secteur 3 : fuselage arrière, moteurs et boîte de transmission principale

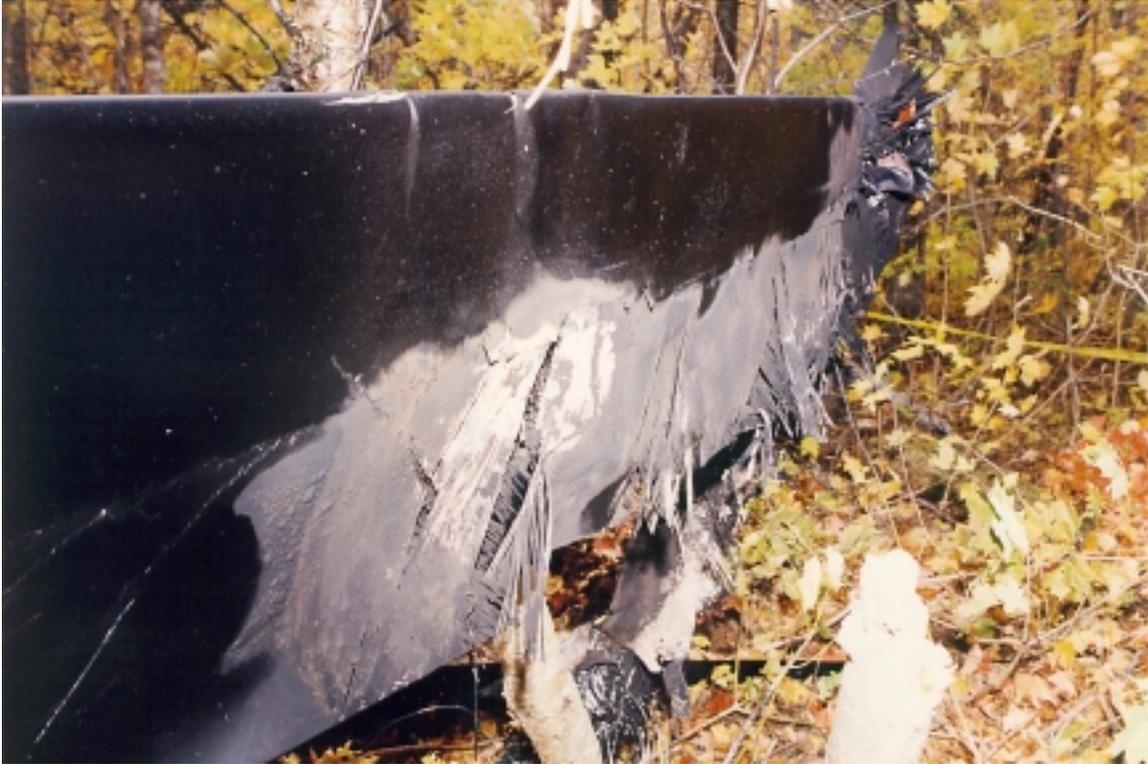
Photo 7 - Site 2 - Burnt Rear Rotor Blade// Secteur 2 : pale du rotor arrière brûlée

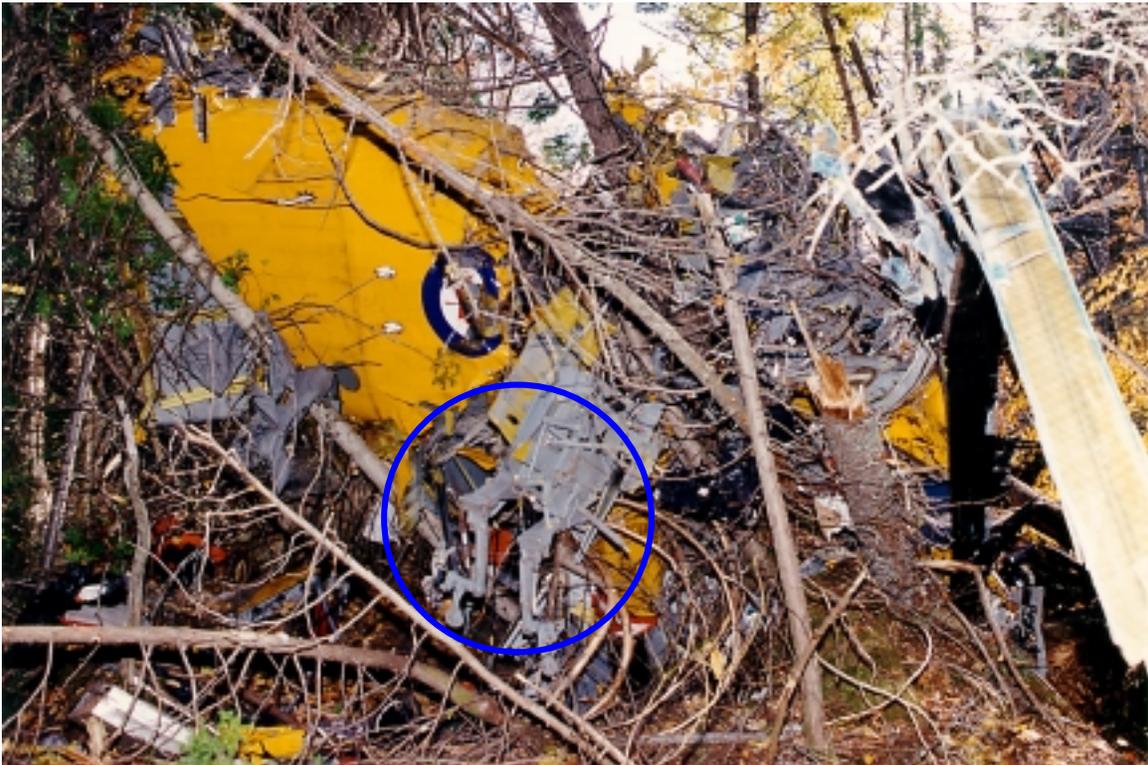
damage but minimal heat and fire damage except for some soot accumulation in the roof of the cabin area at the fuselage break (Photos 8-9). The forward rotor blades showed extensive rotational damage on the leading edge and all were damaged on the trailing edge. Many pieces of cabin equipment showed evidence of heat damage. There was evidence of blade to fuselage contact. The aircraft suffered 'A' Category damage.

Photo 8 - Site 1 - Forward Fuselage, Flight Station (circled) and bottom of aircraft// Secteur 1 : fuselage avant, poste d'équipage (encerclé) et bas de l'appareil

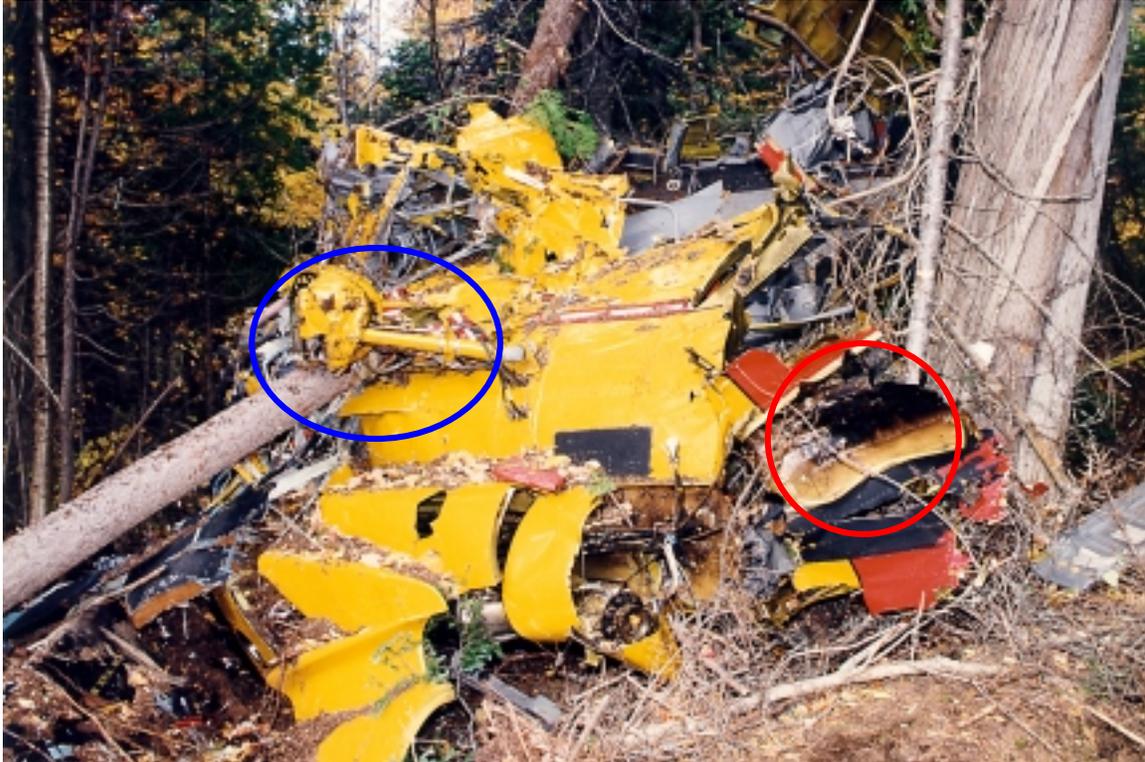
Photo 9 - Site 1 - Top and right side of Fuselage, Rescue Hoist (blue) - note the small fuselage burn top of Sync Shaft Tunnel area (red)// Secteur 1 : haut et côté droit du fuselage, treuil de sauvetage (en bleu) – remarquez la partie brûlée du fuselage en haut du tunnel de l'arbre de synchronisation (en rouge)

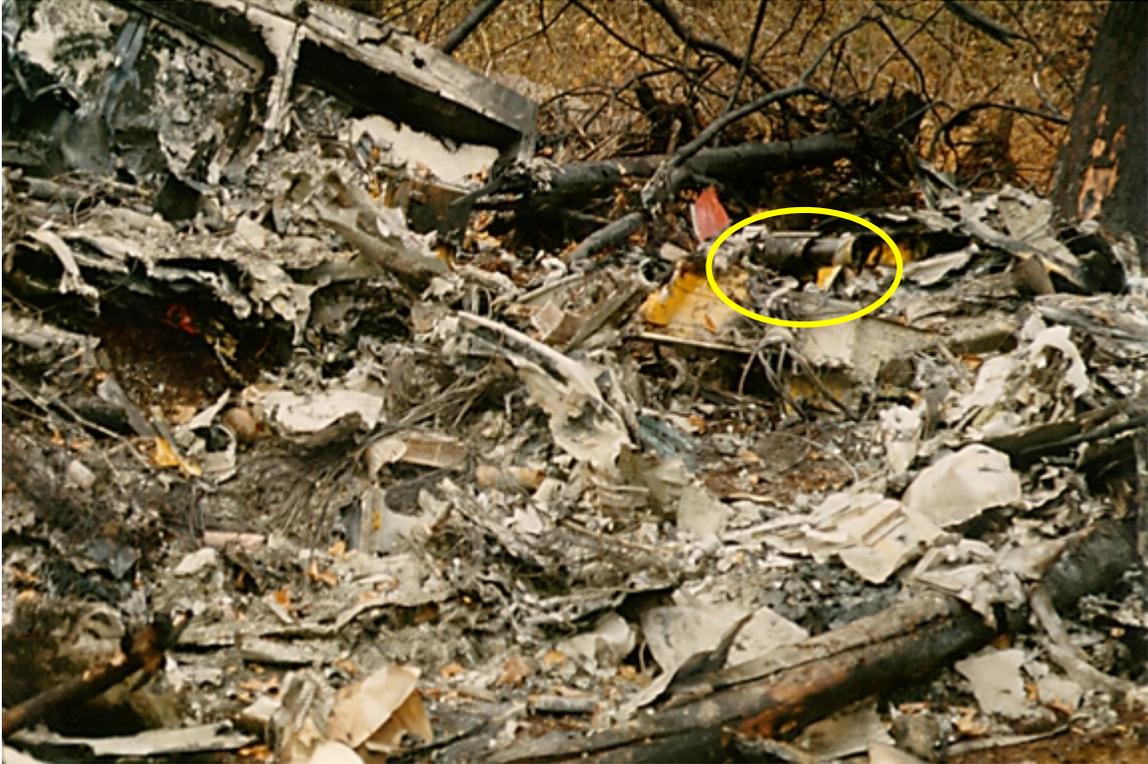
Photo 25 - Left Dump Tube as found on day 3 (retracted and circled)// Tube gauche du vide-vite tel qu'il était lorsqu'on l'a retrouvé au jour 3 des recherches (rentré et encerclé)

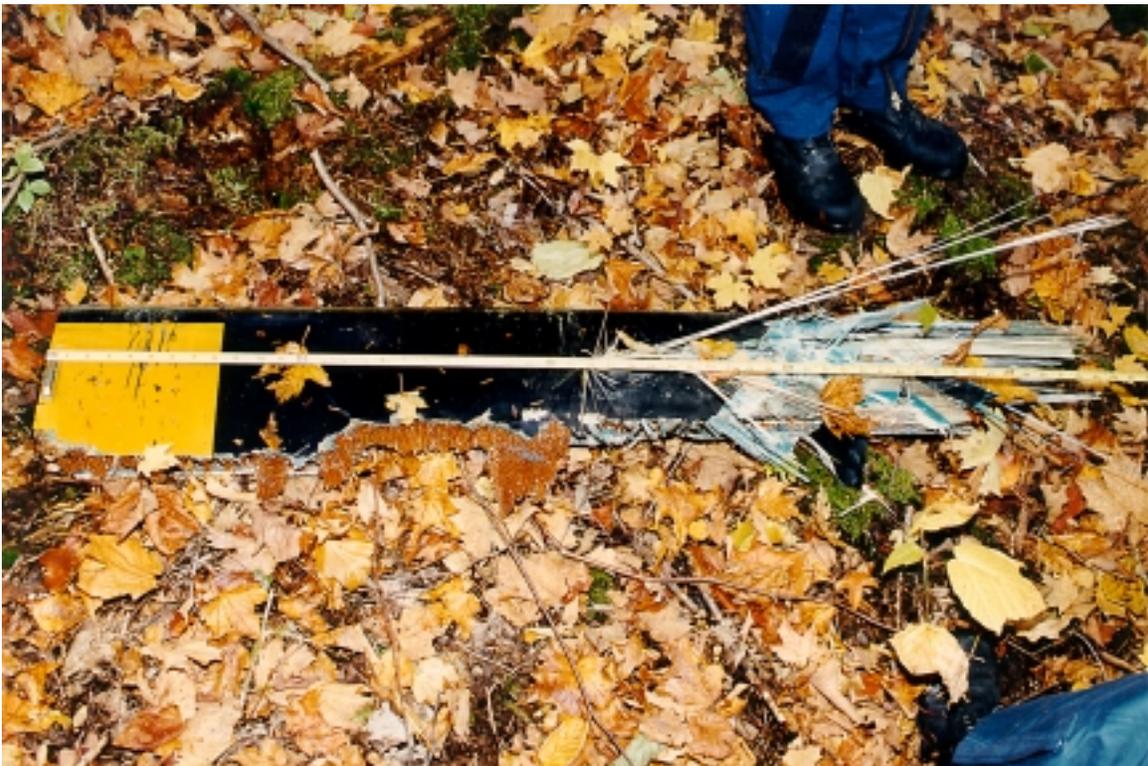
Photo 26 - Rear Rotor Red Blade Fragment - Note the unburned and frayed ends// Fragment de la pale rouge du rotor arrière; remarquez les bouts, non brûlés et « effilochés »

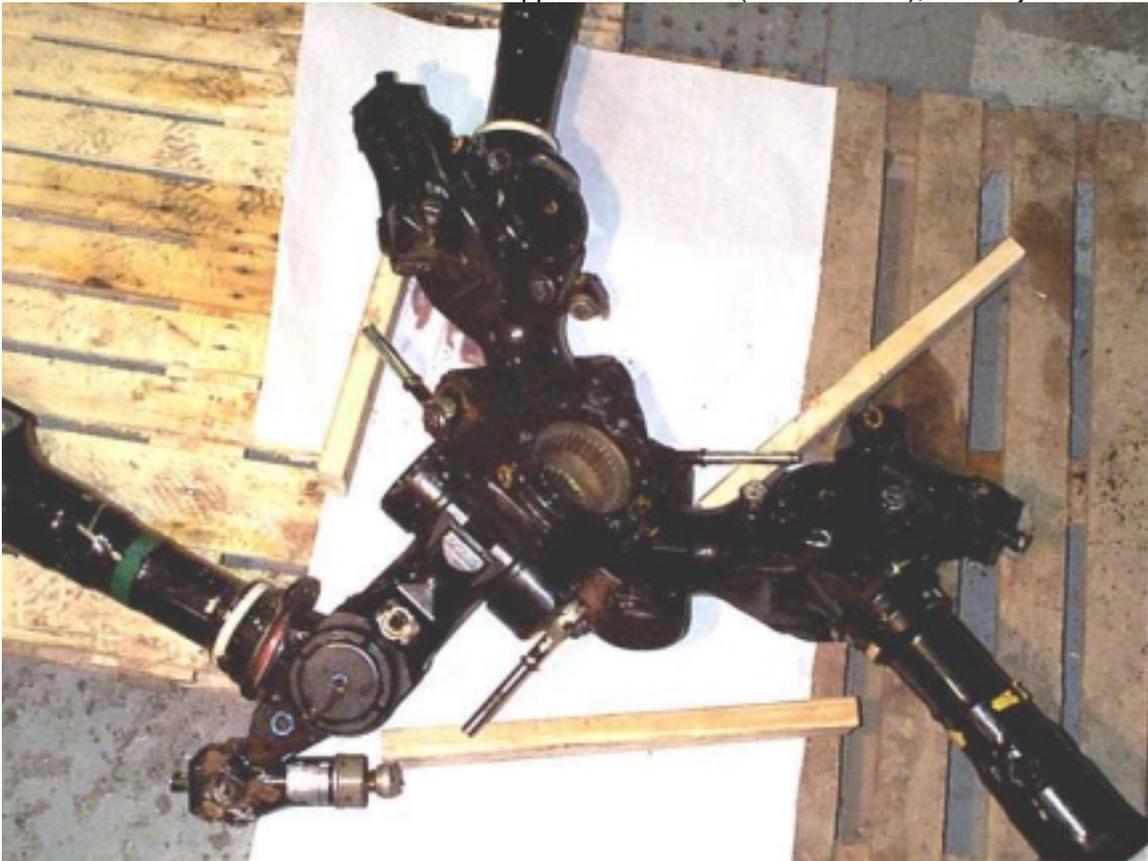
Photo 30 - Rear Rotor Head - Note Damper Failures in full extension// Tête du rotor arrière; remarquez les défaillances des amortisseurs en extension complète

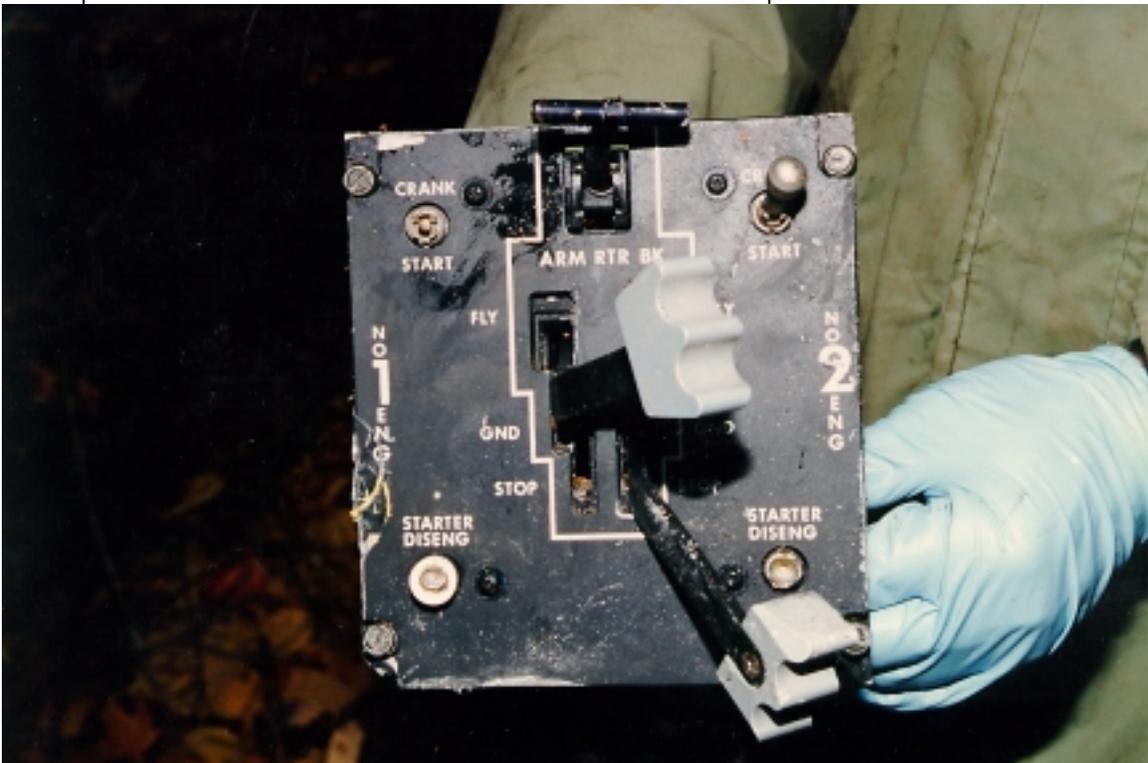
The #2 engine control lever (ECL) was in stop (Photo 31), the engine control actuator (ECA) was in the off position and the fuel control unit (FCU) was closed. The number 2 engine 'T' handle was found seated to the "in" position, damaged and in contact with a piece of wood debris (Photo 32). The number 2 engine oil shutoff valve was found in the open position. The number 2 engine fuel shutoff valve, located in the right stub wing fuel tank, was so badly damaged by fire that its position could not be discerned. All of the corresponding fuel controls on the number 1 engine were found in the fly position.

Photo 31 - Throttle Quadrant - Note Number 2 in "Stop" position// Bloc manettes; remarquez le numéro deux, en position « STOP »

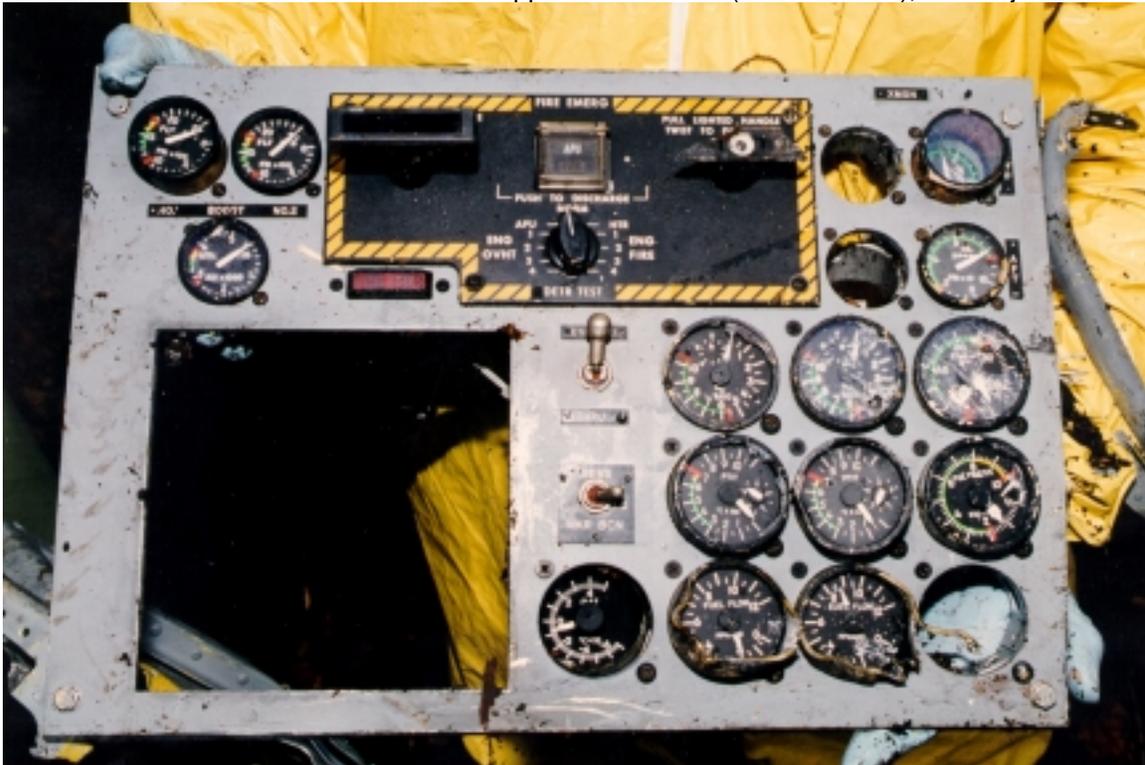
Photo 32 - Fire Extinguisher Control Panel - Note damage to Number 2 "T" handle// Panneau de commande du circuit d'extinction incendie; remarquez les dommages sur la poignée en T numéro 2

Preventive measures implemented as a result of this investigation included Aircraft Operating Instruction (AOI) changes with respect to the fire T-handle being left in the twisted position after its use and ensuring that adequate guidance for aircraft flight

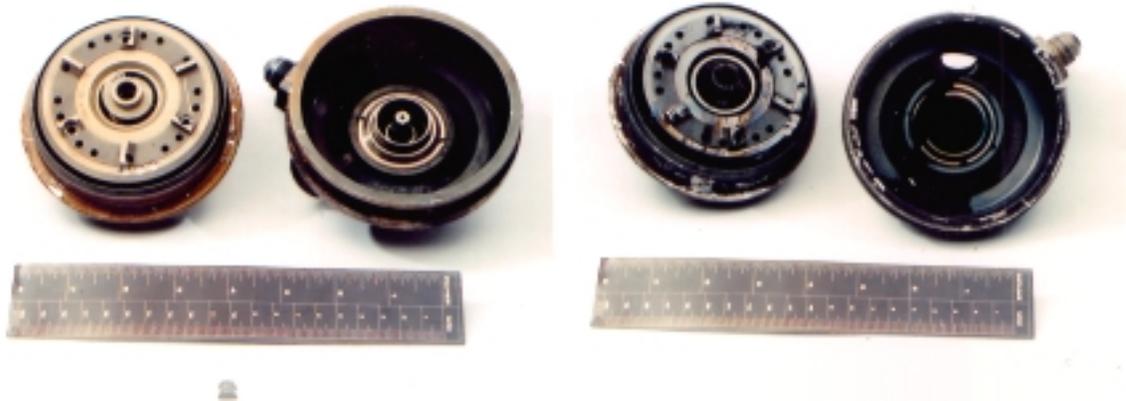
Photo 35 - Inside Views of #2 Engine Centrifugal Fuel Purifier (left) and #1 Purifier (right) - Note similar lack of fuel residues on #2 Purifier // Vues de l'intérieur de l'épurateur carburant centrifuge du moteur numéro 2 (à gauche) et de l'épurateur du moteur numéro 1 (à droite); remarquez, ici encore, l'absence de résidus de carburant dans l'épurateur du moteur numéro 2

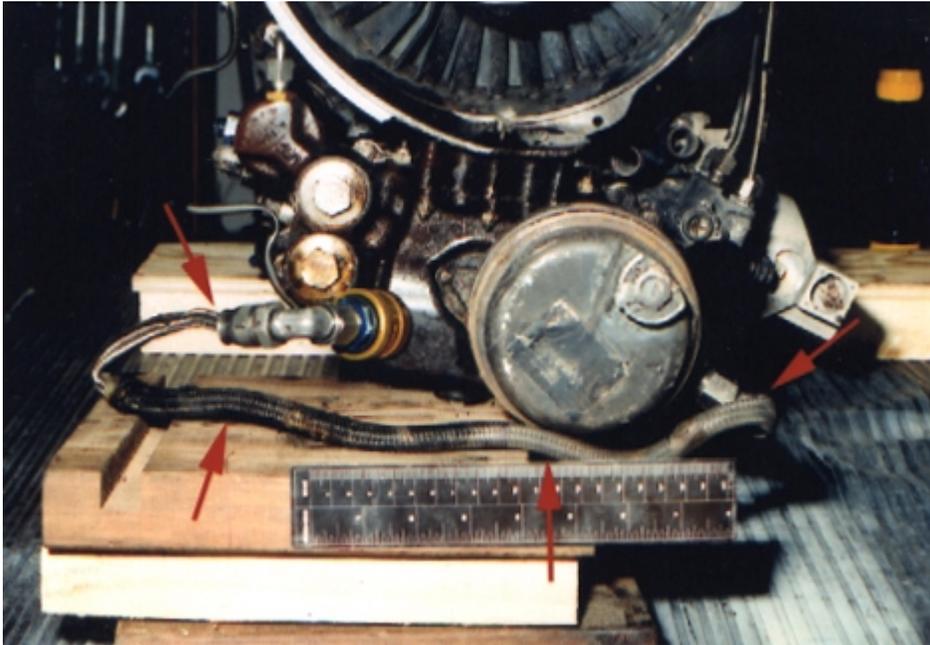
Wreckage examination showed a fuel leak in the #2 engine compartment of CH11305 resulted in an in-flight fire. In the process of responding to the fire, the crew shut down the engine, activated the fire extinguishing system using the T-handle and commenced fuel dump procedures. The right hand dump tube did not extend during the fuel dump sequence; this increased the possibility of fuel to fuselage contact. The #2 fire T-handle was reset prior to the in-flight break-up; re-introducing fuel and oil into the engine compartment after the fire extinguishing system had been activated, likely re-igniting the fire or causing a small explosion in the # 2 engine compartment. During these actions the dumped fuel was ignited and this set off a catastrophic series of events causing rear rotor blade to fuselage contact and the break-up of the aircraft. Forces precipitated by the aircraft break-up and subsequent ground impact caused fatal injuries to all six crew members.

Photo 37 - #2 Engine Main Fuel Line (suspected location of original fuel leak - Note fire damage to cable) // Conduite principale d'alimentation en carburant du moteur numéro 2 (que l'on suppose être à l'origine de la première fuite de carburant; remarquez les dommages que le feu a causés au câble)

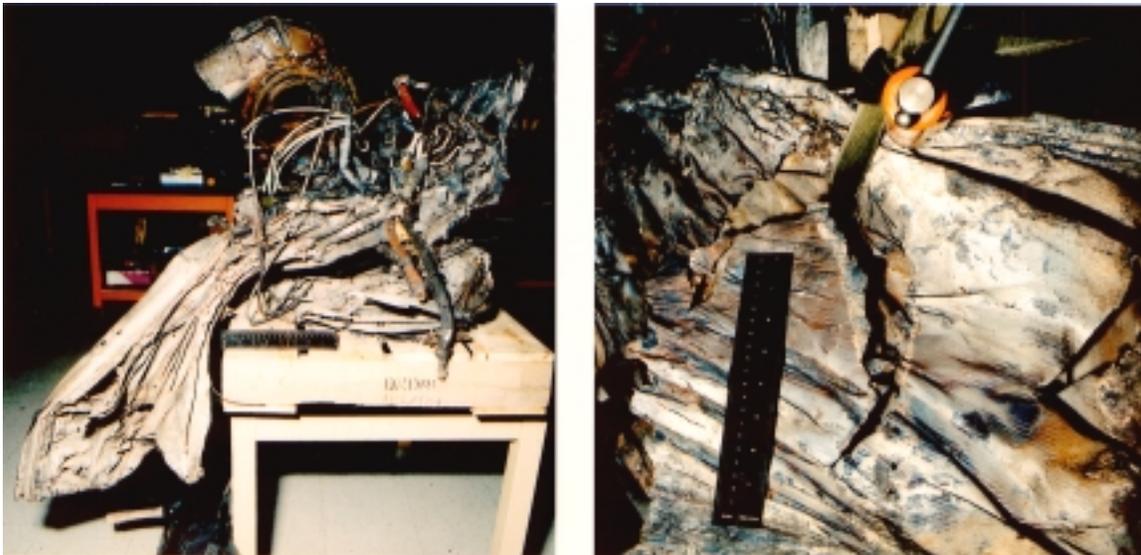
Photo 42/43 - Right (Number 2) Engine Access Door - Note the Severe "accordion" effect on the structure that had heat damage on interior folds when stretched // Porte d'accès au moteur de droite (numéro 2); remarquez l'important effet « accordéon » de la structure, qui présente des dommages imputables à la chaleur lorsqu'on l'étire

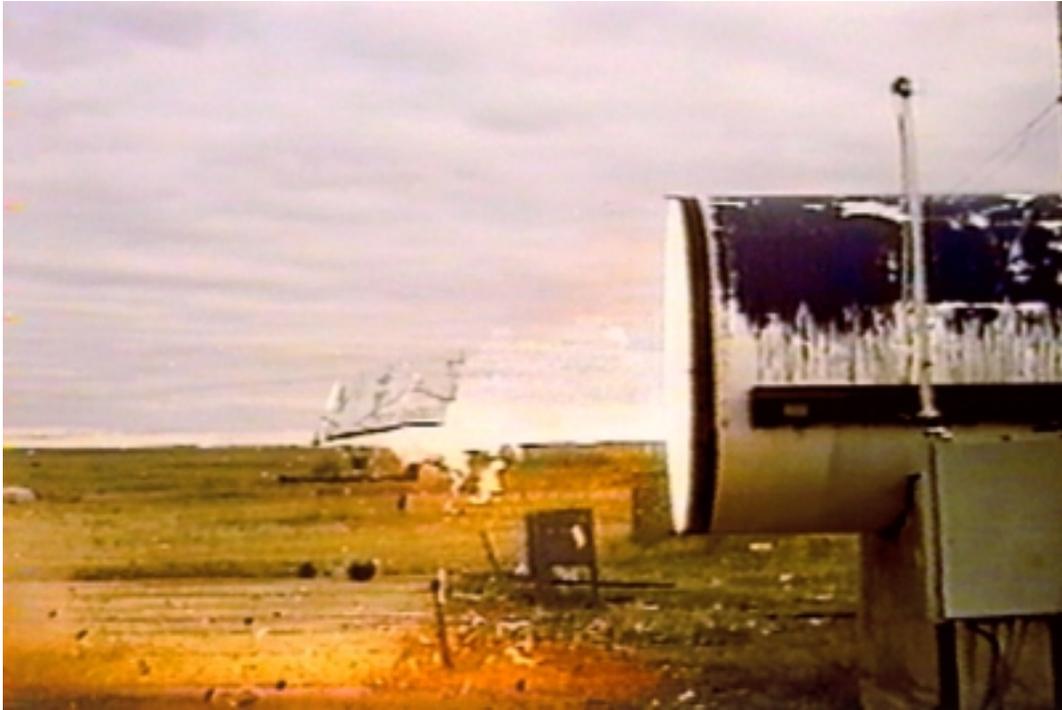
Photo 44 - DRES Engine Door Blast Experiment - Note simulated blast door exiting structure // Expérience du CRDS portant sur l'ouverture de la porte d'accès au moteur lors d'une explosion; remarquez la reproduction de la porte qui est projetée hors de la structure

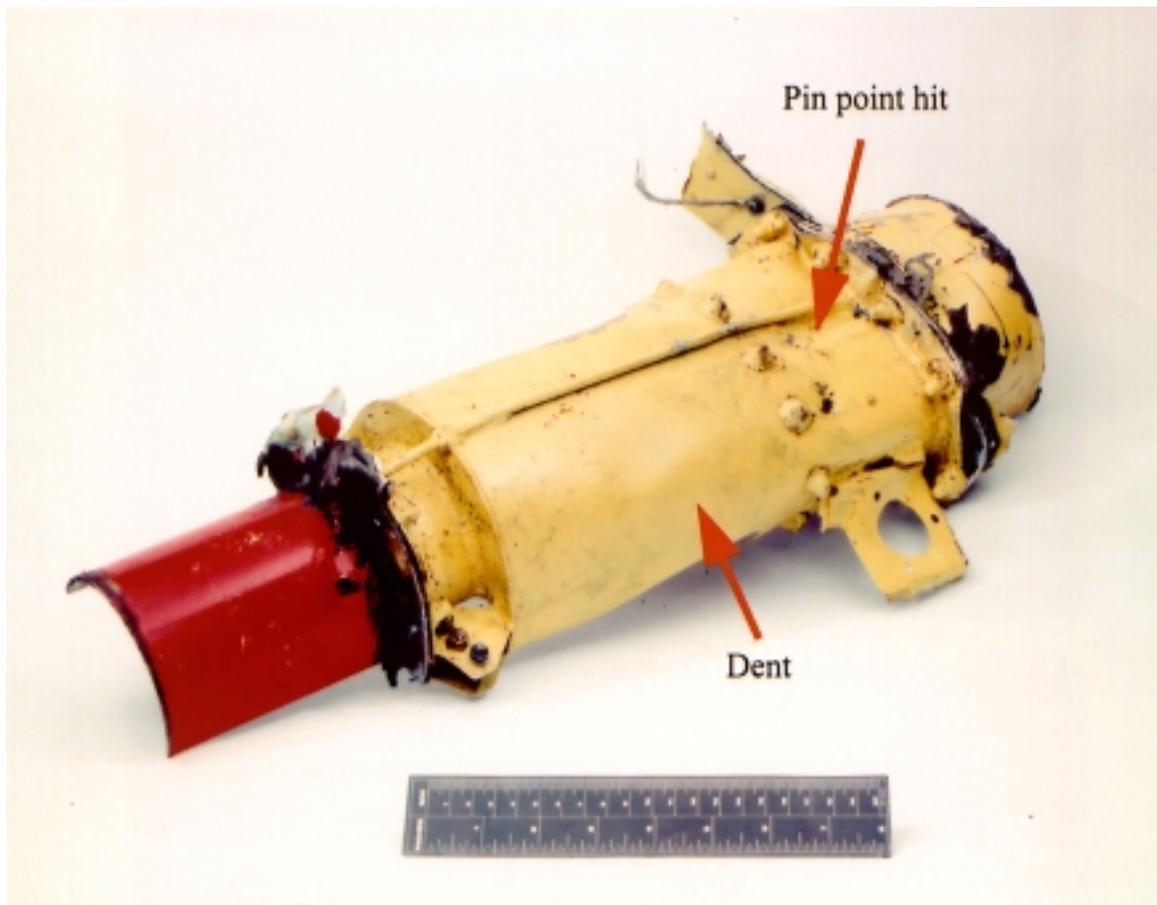
Photo 47 - RH Dump Tube and exterior view of puncture strike// Tube droit du vide-vite et vue extérieure des perforations

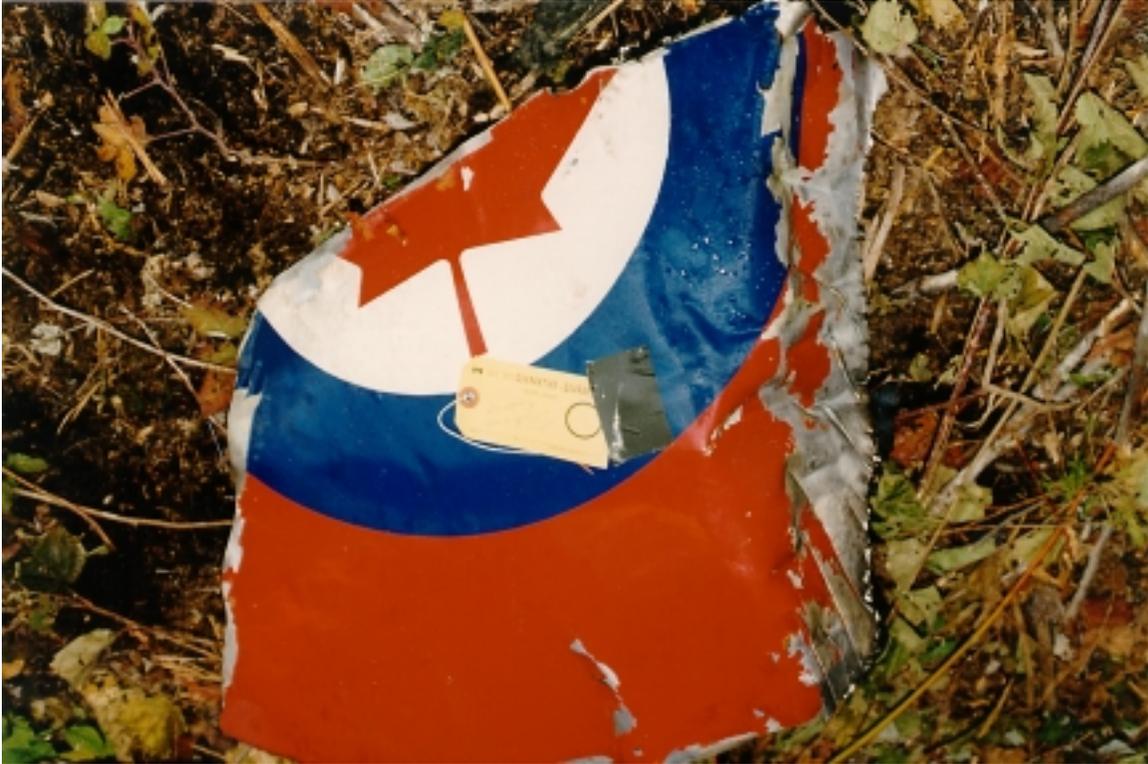
Photo 56 - Section of Left Stub Wing Fuel Tank - Note High Energy Impact created folds on right and no fire damage// Section du réservoir de carburant du moignon d'aile gauche; remarquez que la force de l'impact a plié la partie droite du réservoir et que le feu ne l'a pas endommagée
