Aircraft Accident Summary
Résumé d'accident d'aéronef

TYPE: CH11305 Labrador

DATE: 02 October 98

**LOCATION: 3 NM South of
Marsoui QC.**

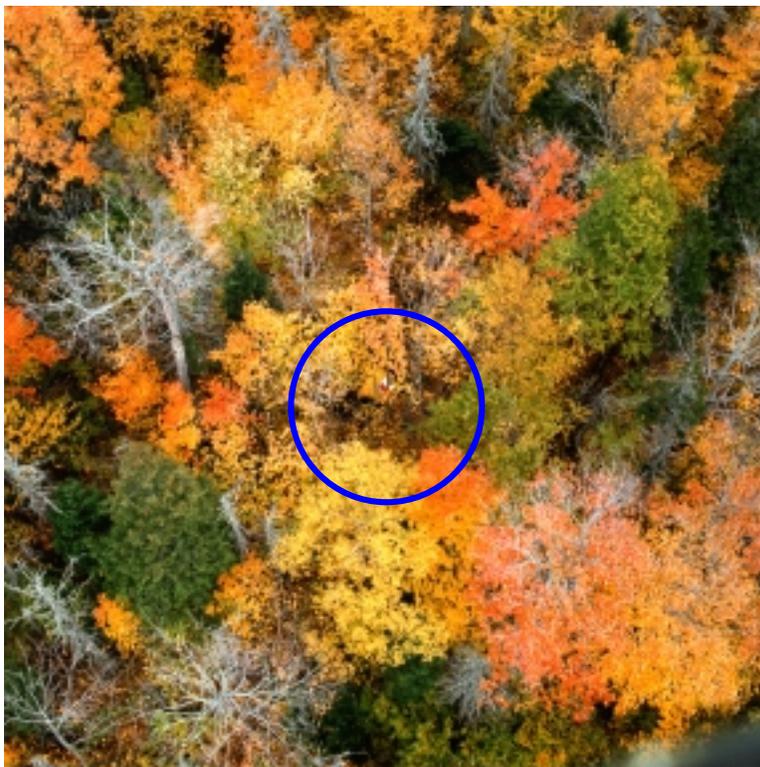
The aircraft broke into three main pieces: the forward fuselage, aft pylon and aft fuselage (Photos 1-4). The fuselage separated at flight station (FS) 220, just behind the spotter seat positions and the aft pylon separated at waterline 71, just below the Canada flag. The three sections fell separately at near vertical angles. The post crash fire extensively damaged the aft fuselage (Photo 5). The aft pylon section showed minimal rotational damage to either the rotor blades or aft pylon shaft (Photo 6). The rear red blade sustained extensive burn damage (Photo 7), the rear yellow blade sustained some fire damage, the remaining aft blade (green) showed no heat damage but did have soot deposits. The aft pylon sustained heat damage in the vicinity of the Auxiliary Power Unit (APU) and the utility hydraulic reservoir. The forward fuselage sustained massive structural

Photo 2 - Site 2 Rear Pylon (circled)// Secteur 2 : pylône arrière (encerclé)

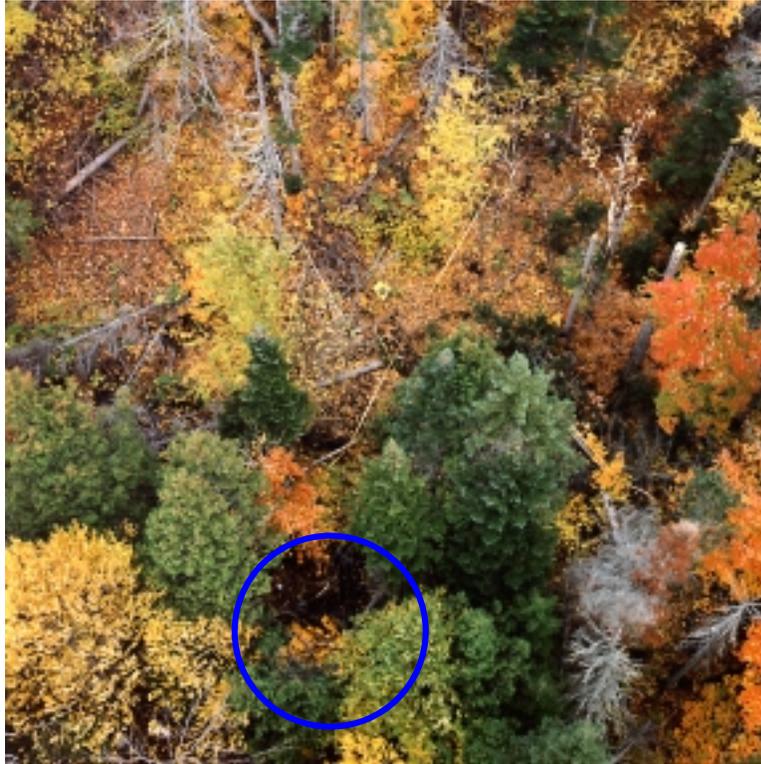
Photo 3 - Site 1 - Forward Fuselage, Flight Station (circled) and Crews Location// Secteur 1 : fuselage avant, cabine de pilotage (encerclée) et emplacement des membres d'équipage

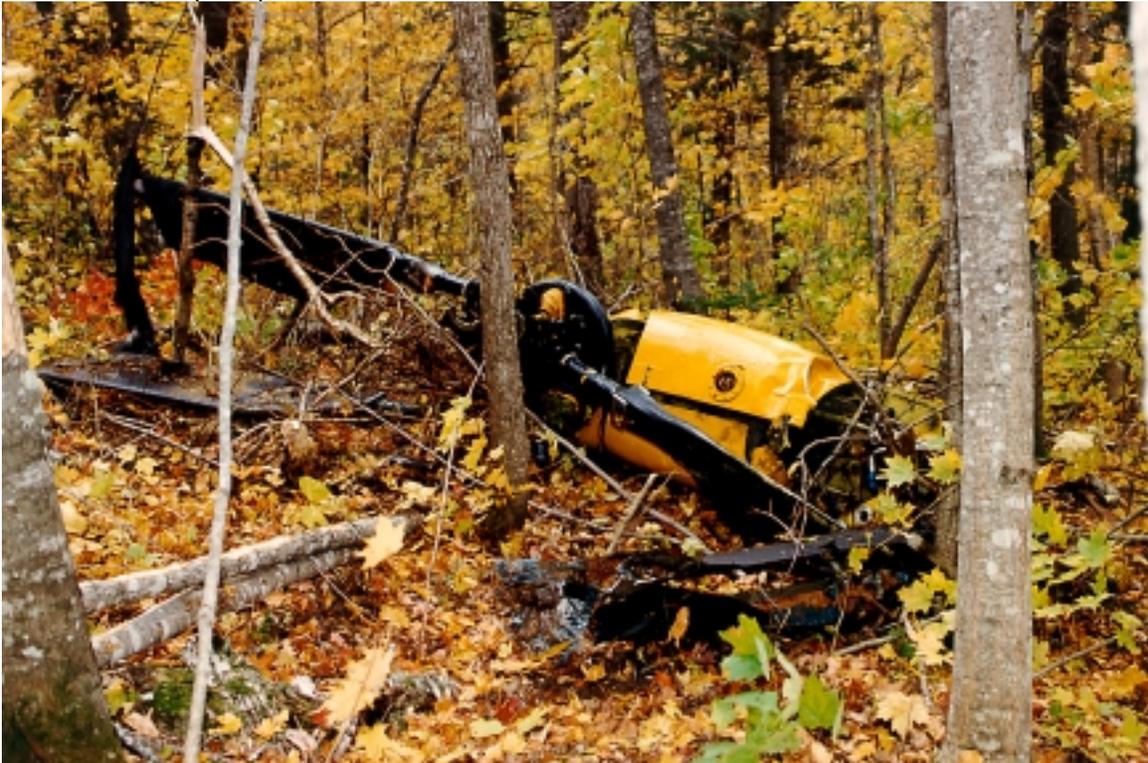
Photo 6 - Site 2 Rear Pylon and Rear Rotor blades (note undamaged surrounding trees)// Secteur 2 : pylône arrière et pales du rotor arrière (remarquez les arbres intacts)

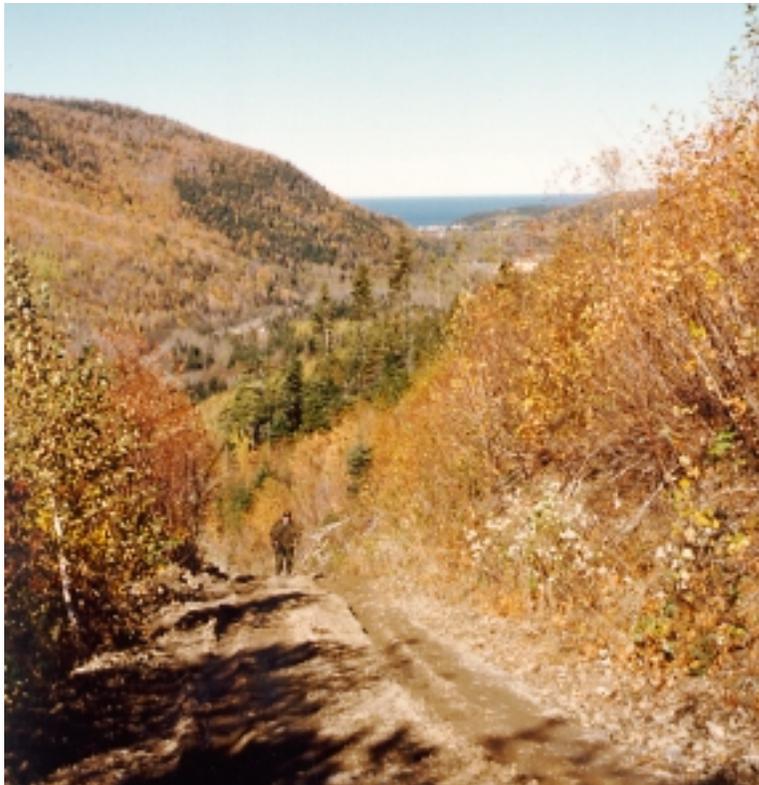
The aircraft crashed on crown land. The access road used by the investigation team is privately owned (Photo 10). Considerable wear in the first three days of the investigation resulted in road repairs by a local contractor. The area used for the base camp (Photo 4) was altered to accommodate the required tenting and equipment and this impinged on the land of the same owner. Roadwork to build an access for aircraft salvage resulted in further damage to private property; however, best possible repairs were made when the site was vacated. Environmental clean up was conducted by the recovery and salvage team in the three main crash sites. The landowner did not indicate that a claim would be made against the crown for the changes made on the property.

Photo 10 Road to Upper Recovery Location (see photo 4)// Chemin menant au secteur supérieur de récupération des débris (voir la photo 4)

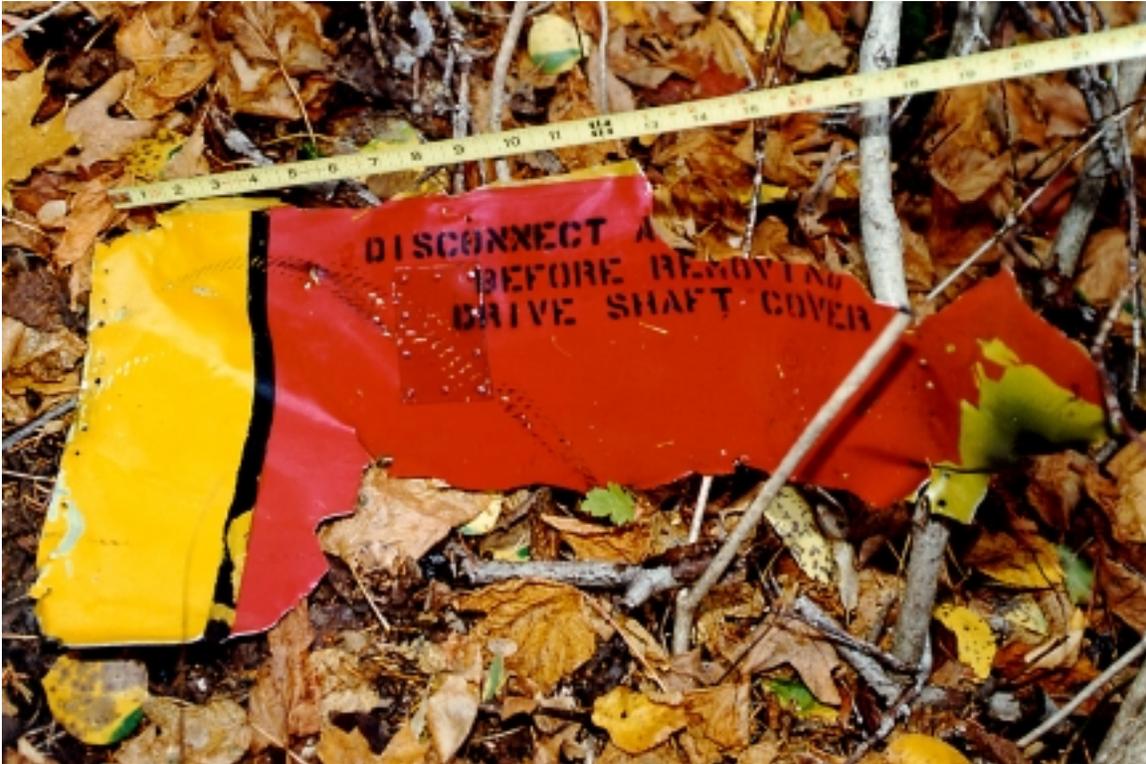
Photo 11 - Debris in Upper Field - Sync Shaft Tunnel Cover// Débris récupérés dans le secteur supérieur : carter du tunnel de l'arbre de synchronisation

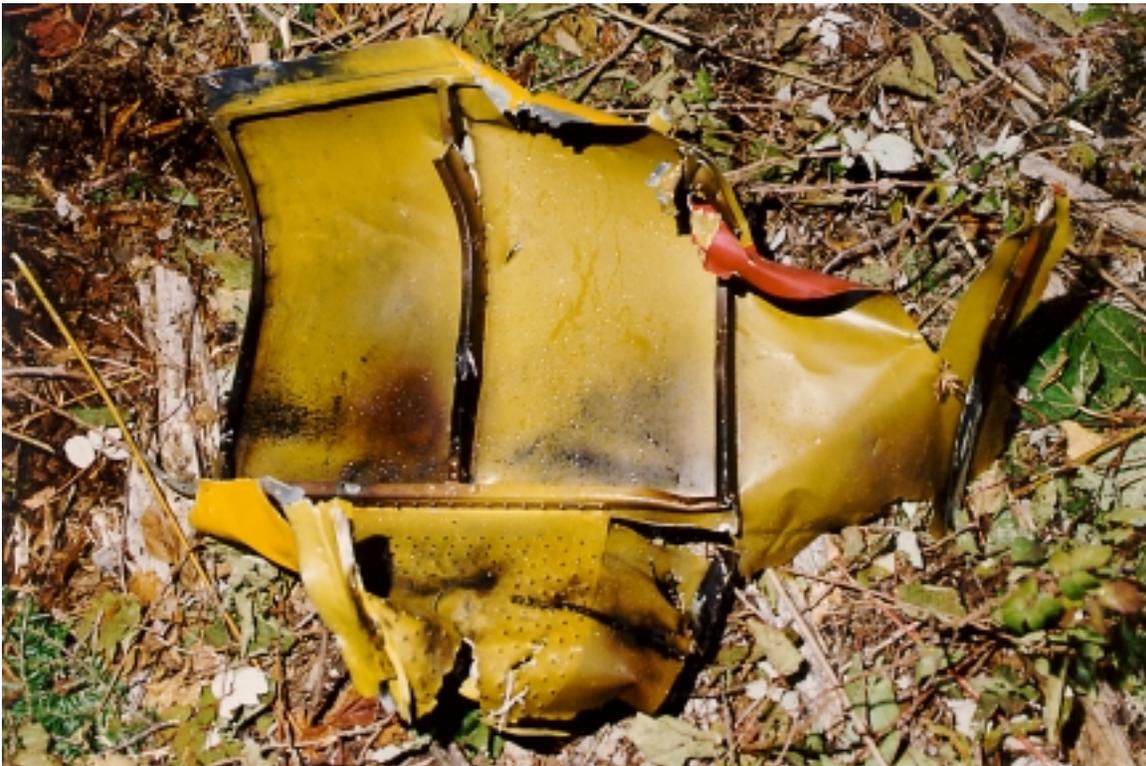
Photo 12 - Debris in Upper Field - Tunnel Cover Removed during first blade to fuselage strike (note soot on inside right)// Débris récupérés dans le secteur supérieur : carter du tunnel arraché lors du premier contact entre les pales et le fuselage (remarquez la suie sur le côté droit de la surface intérieure)

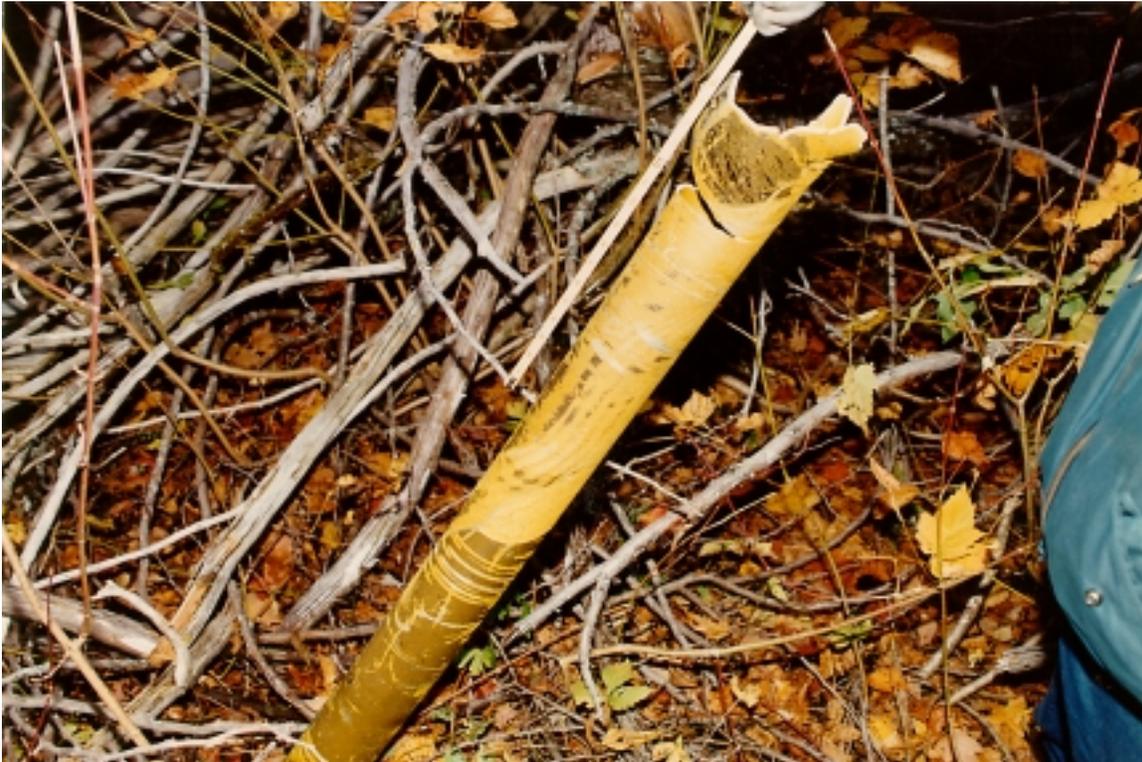
Photo 13 - Sync Shaft Fragment - Upper Debris field//– Morceau de l'arbre de synchronisation récupéré dans le secteur supérieur

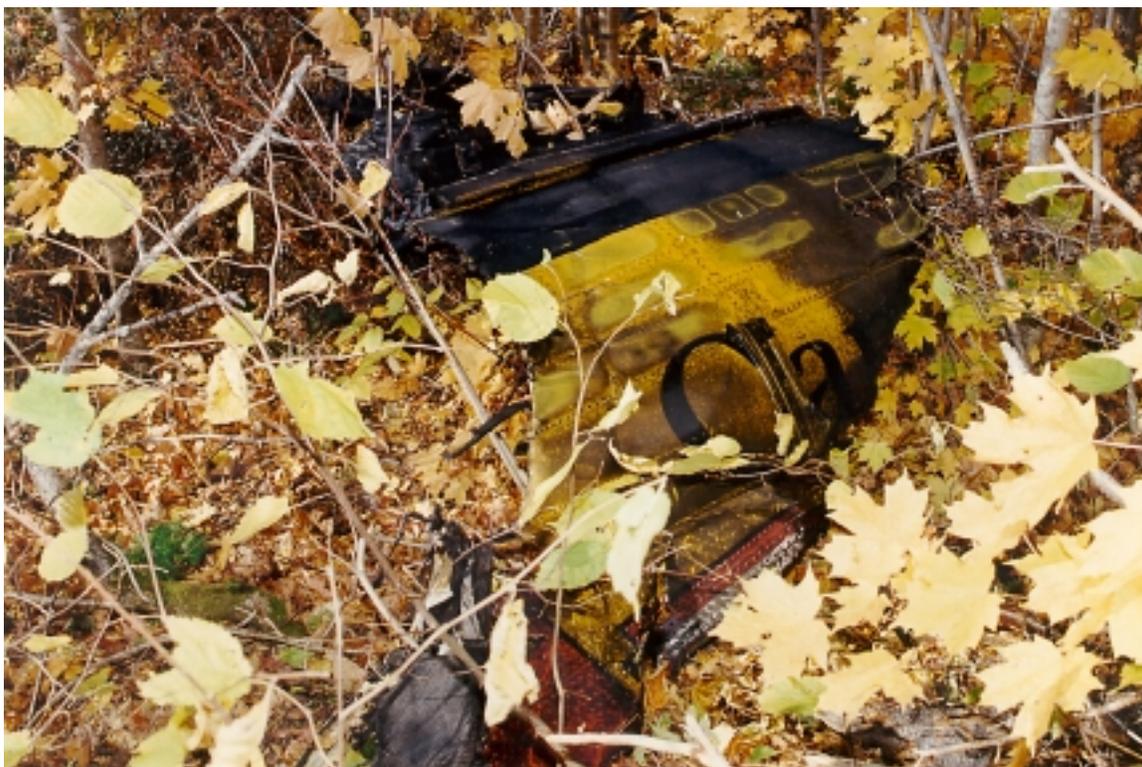
Photo 14 - Debris in Upper Field - Rear fuselage// Débris récupérés dans le secteur supérieur : fuselage arrière

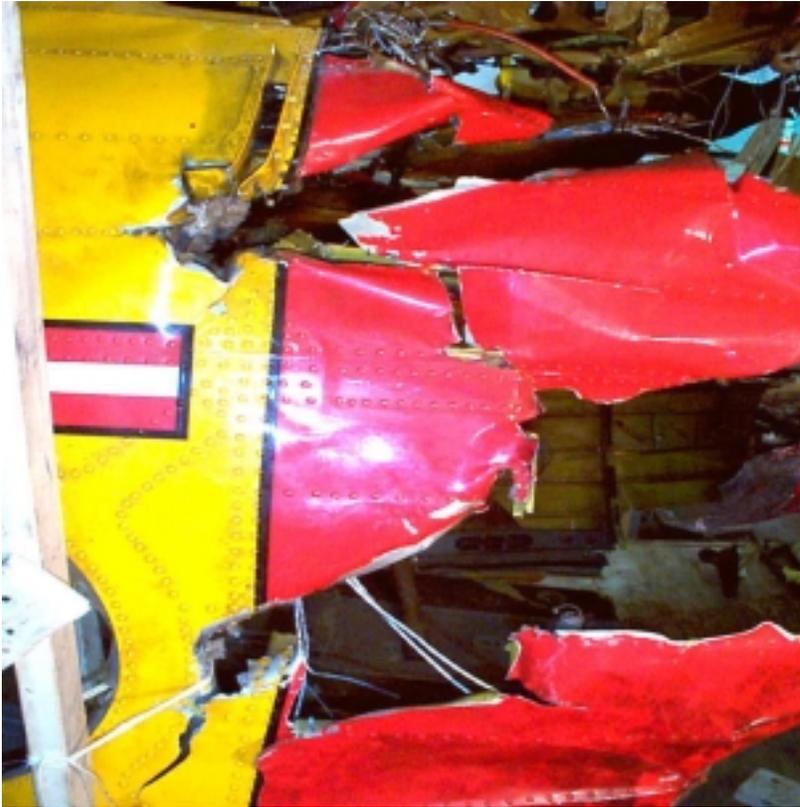
There were marks from four rotor blade strikes on the side fuselage of the aircraft, starting at the upper tunnel area and extending down to the floor in the area of the left spotter's seat (Photo 15). Corresponding marks on the rear rotor blades showed all four cuts into the fuselage had been made by two of the three rear rotor blades (Photo 16).

The marks, scratches and indents on the blades were examined with direct reference to the fuselage punctures. This revealed that only two of the three rear rotor blades made all four of the fuselage cuts. The two conspicuous sequential blade punctures on the side of the aircraft (photos 15 & 16) are the correct relative length for a complete blade and the right distance, on an intact aircraft, from the rear rotor hub. Further, the blade that did not enter the aircraft was found intact. This is clear evidence that there was no failure of the rear blade structures before the blade to fuselage contact. Also, the "first strike" tunnel cover was at the start of the debris field and it was collocated with small pieces of blade material. This combination of facts indicates that the blade to fuselage contact was the mechanical mechanism that precipitated the in-flight break up.

Photo 15 - Blade Strike holes in Fuselage// Perforations causées par les contacts entre les pales et le fuselage

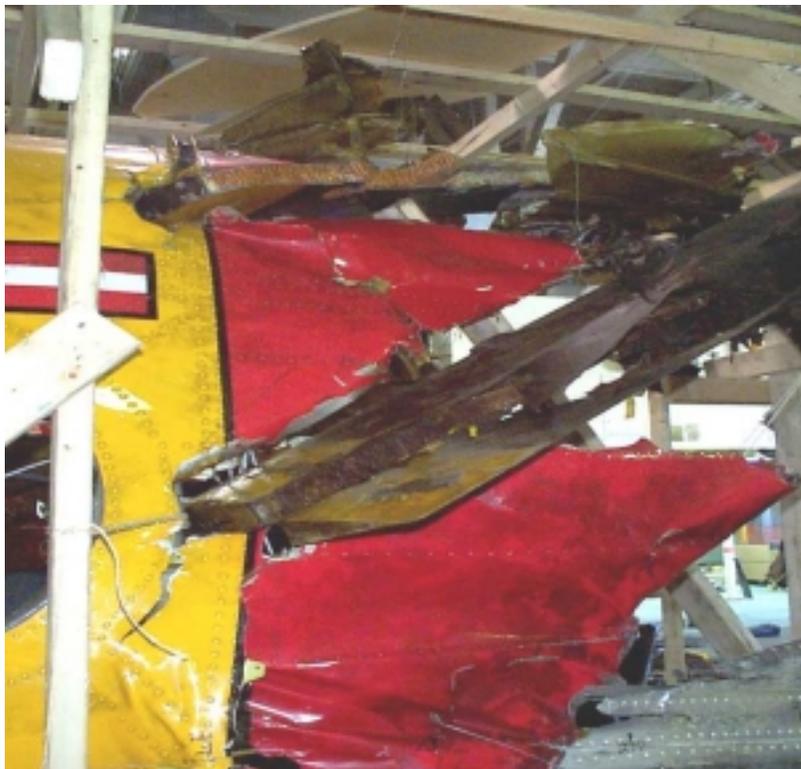
Photo 16 - Blade Pieces Inserted in Fuselage (confirming only 2 blades made all 4 cuts in fuselage).// Morceaux de pales enfoncés dans le fuselage (confirmant que les quatre entailles dans le fuselage sont attribuables à deux pales).

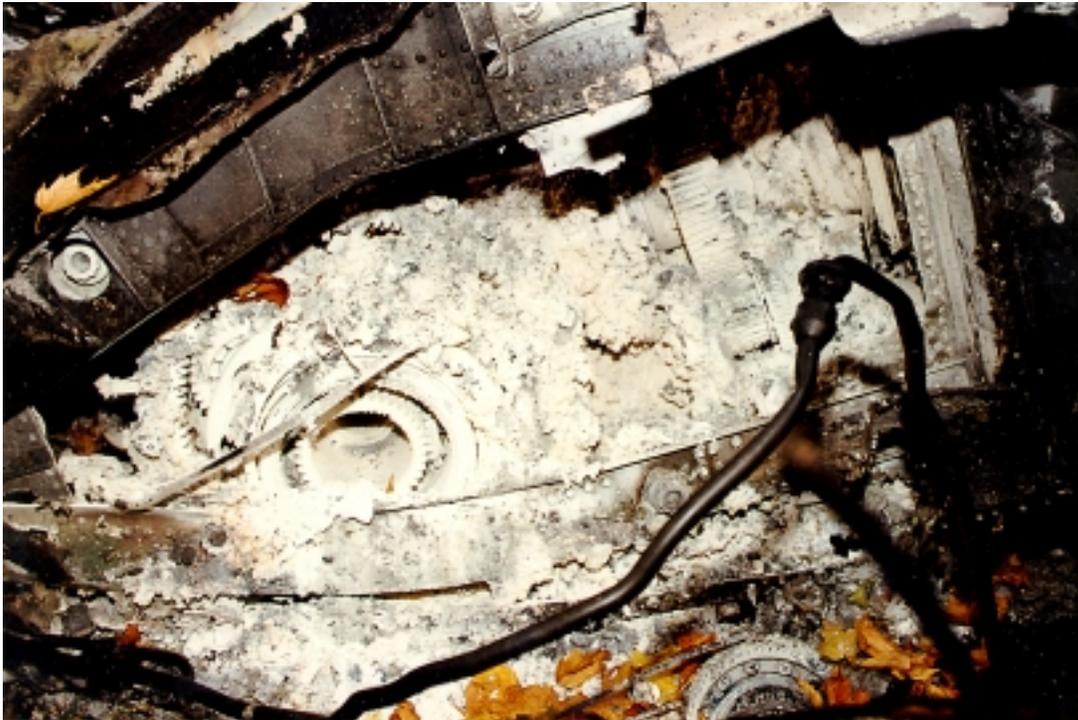
Photo 17 - MGB Gears and Ash of Outer Casing// Engrenages de la boîte de transmission principale et cendres du carter extérieur

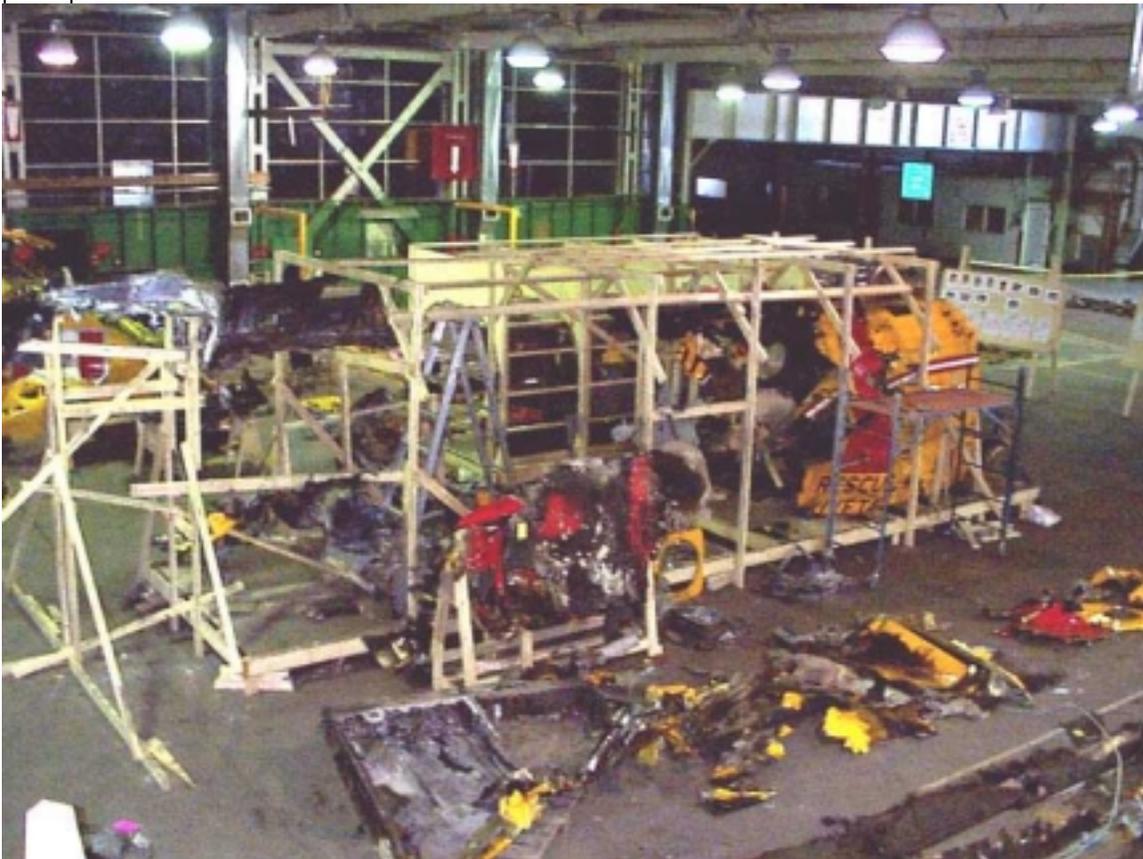
With the wreckage in Ottawa, structural jigs were constructed to facilitate the three-dimensional re-build of the aircraft (Photo 18). Also, the debris was laid out in its relative location before the break-up so that damage patterns could be examined and the break-up sequence determined (Photo 19). This approach allowed direct correlation and comparison of damage sustained to the various aircraft components in the accident. This process revealed that the areas of greatest concern were located in the rear of the aircraft, thus the re-construction concentrated aft of Flight Station (FS) 160 (just aft of the forward entry hatch). All aircraft components recovered to the rebuild site were examined for relevance to the accident but, for the most part, only the components in the cockpit and aft of FS 160 contributed to an understanding of the events.

Photo 18 - Rebuild of Ch11305 - Right side// Reconstitution du CH11305 : côté droit

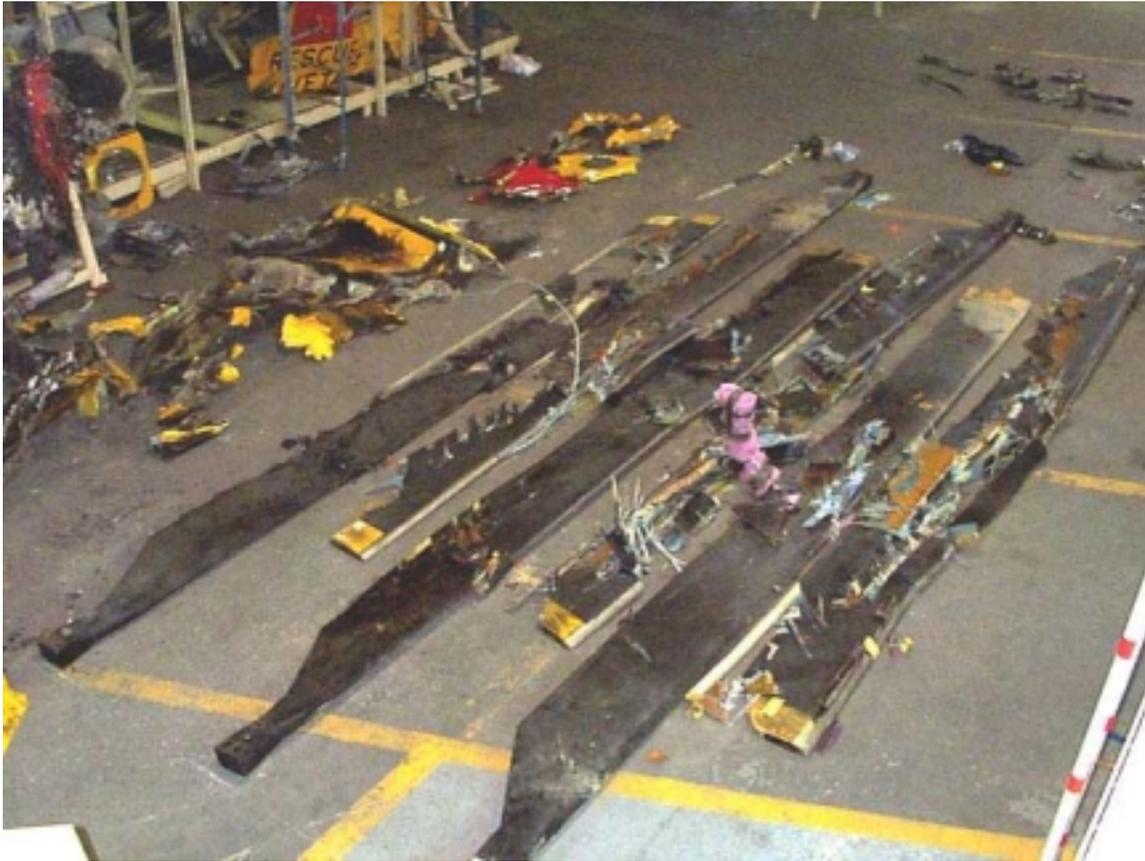
Photo 19 - Rebuild of Rotor Blades// Reconstitution des pales de rotor

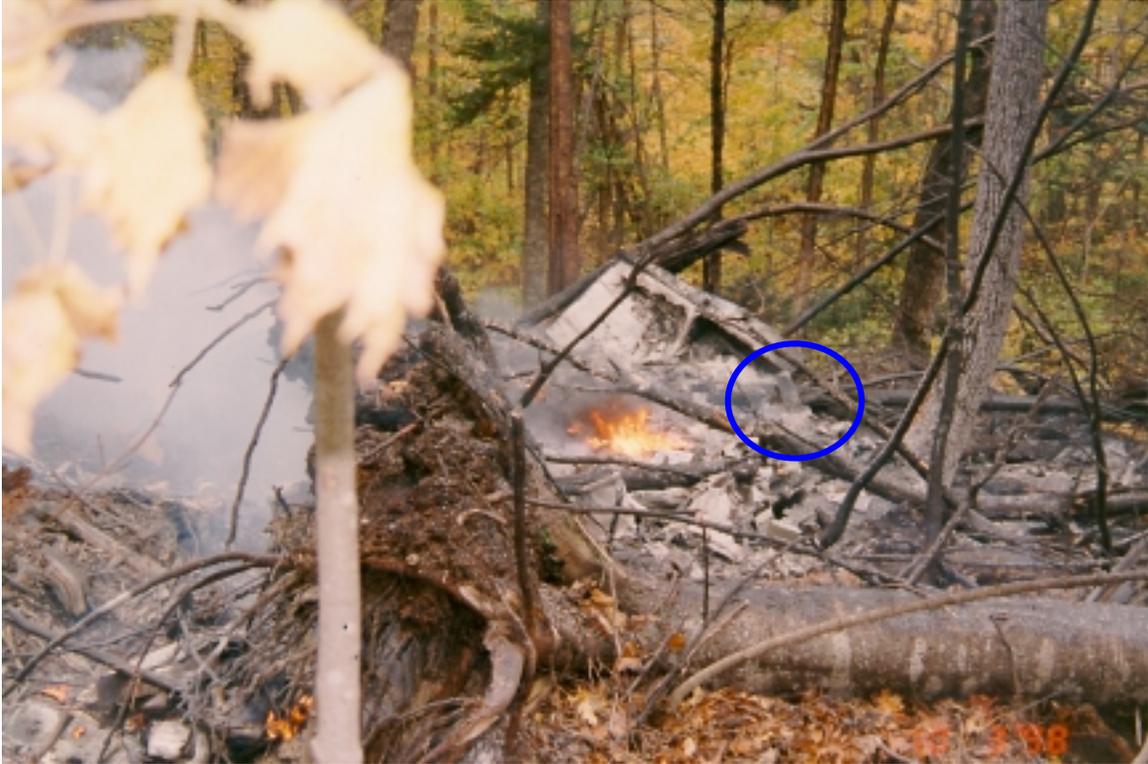
Photo 23 - Left Dump Tube (extended and circled) in post-crash fire// Tube gauche du vide-vite (en extension et encerclé) lors de l'incendie ultérieur à l'écrasement

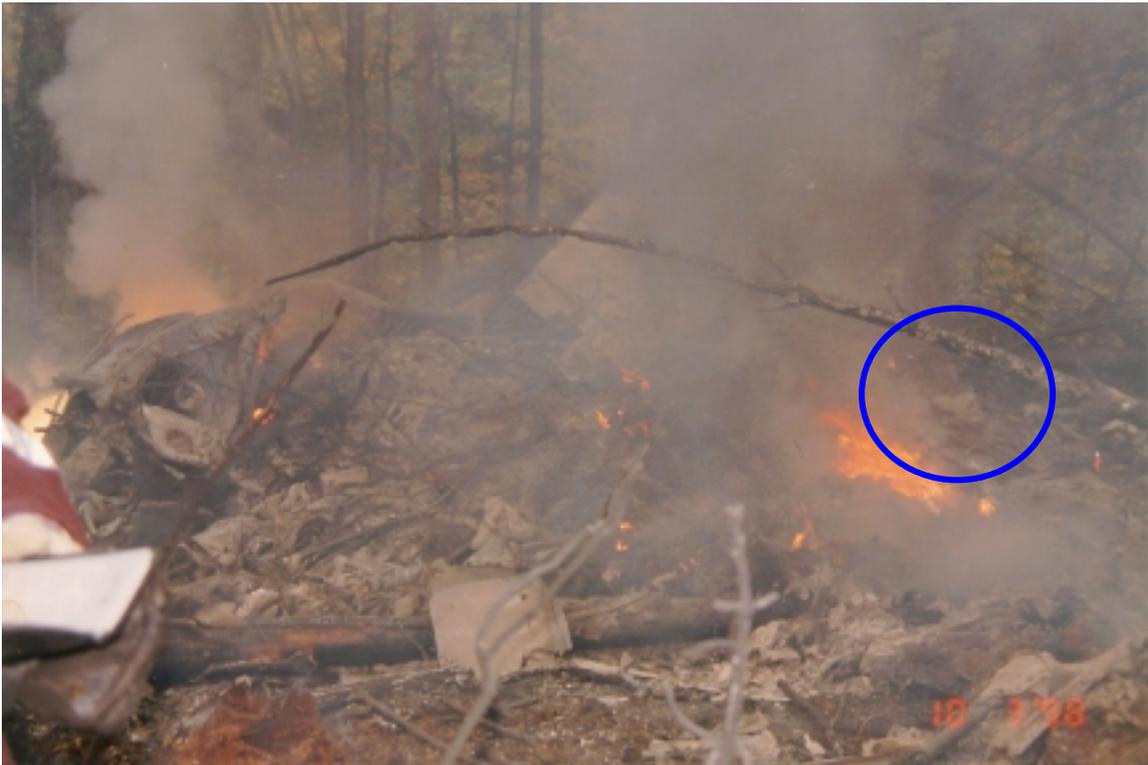
Photo 24 - Left Dump Tube (extended and circled) in fire immediately post crash// Tube gauche du vide-vite (en extension et encerclé) lors de l'incendie, immédiatement après l'écrasement

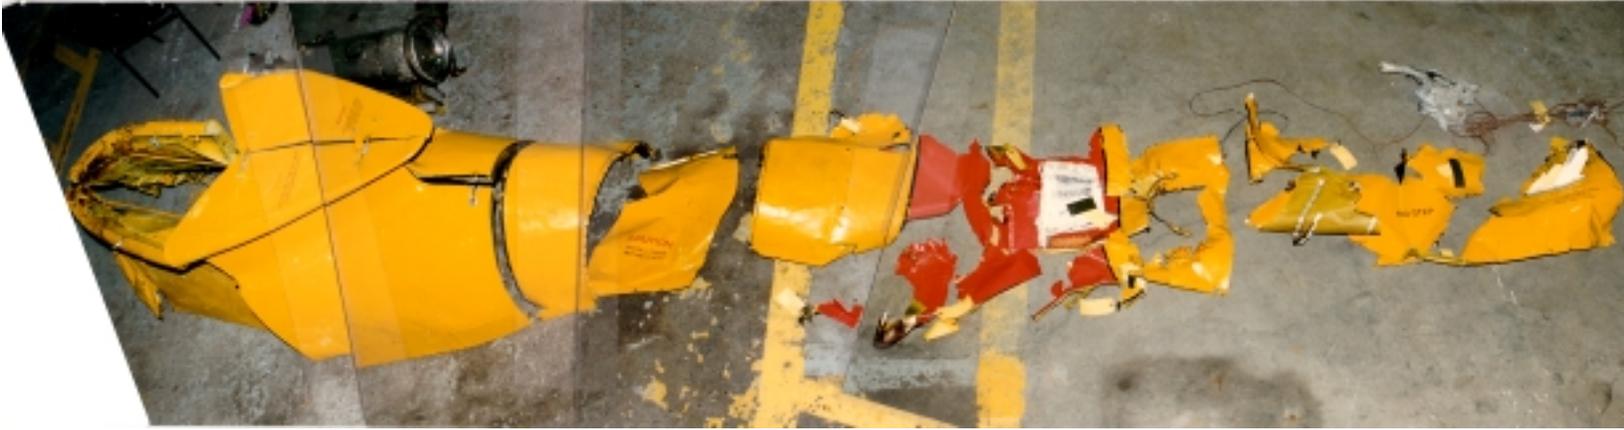
Photo 27 - Sync Shaft Tunnel Cover Re-build (exterior)// Reconstitution du carter du tunnel de l'arbre de synchronisation (extérieur)

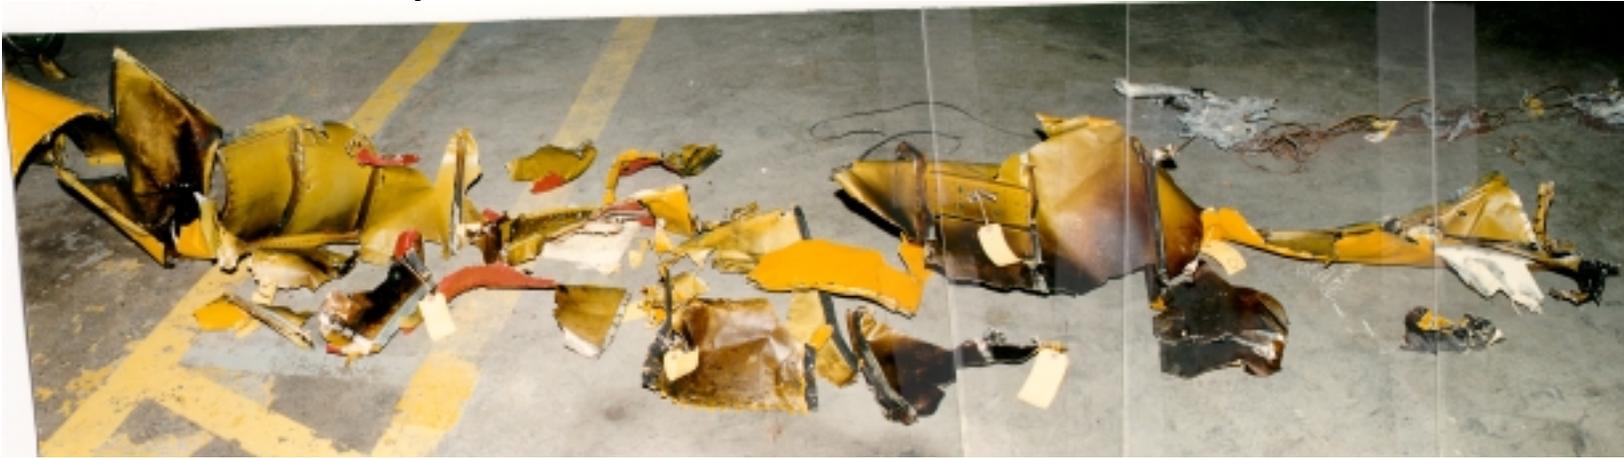
Photo 28 - Sync Shaft Tunnel Cover re-build (interior)(note soot on interior right side)// Reconstitution du carter du tunnel de l'arbre de synchronisation (intérieur) (remarquez la suie à l'intérieur, sur le côté droit)

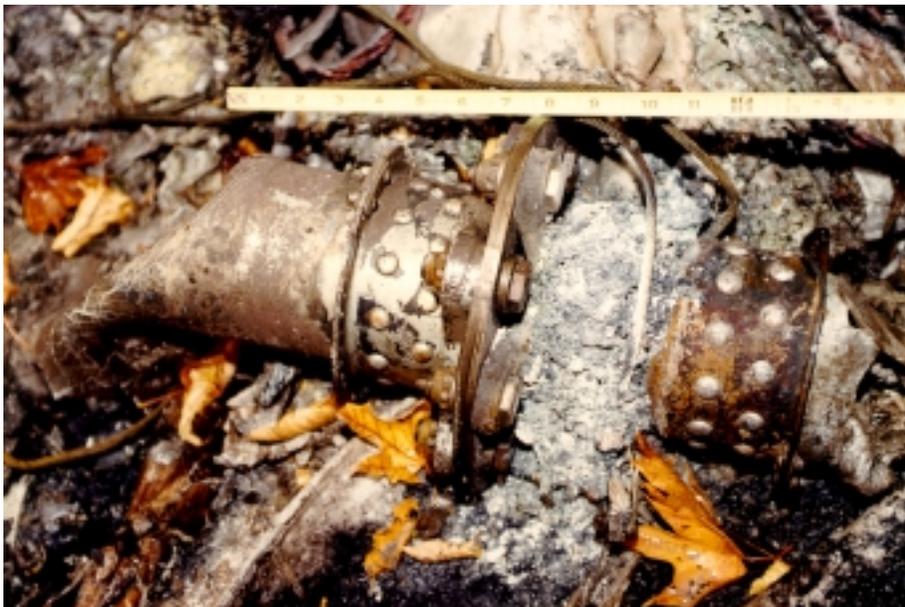
still attached (Photo 29). This damage pattern suggested these sections of the sync shaft were melted in the post crash fire.

Photo 29 - Thomas Coupling and melted Sync shaft sections// Raccordement de Thomas et sections fondues de l'arbre de synchronisation.

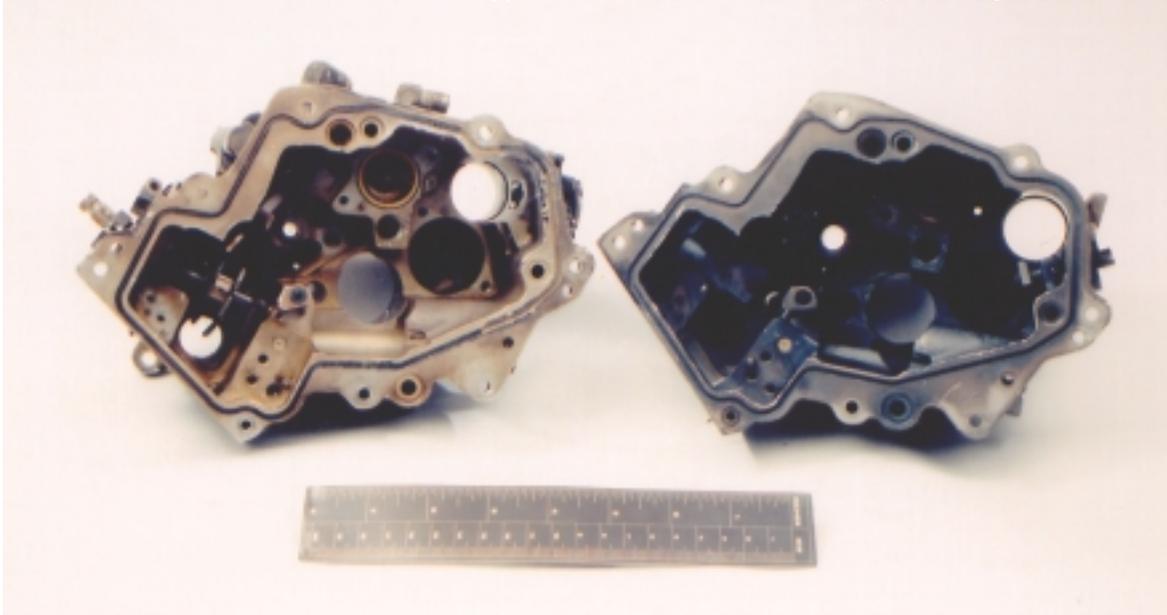
Photo 34 - Inside Views of #2 Engine Fuel Control Unit (left) and #1 FCU (right) - Note the lack of fuel residues on #2 // Vues de l'intérieur du régulateur de carburant du moteur numéro 2 (à gauche) et de celui du moteur numéro 1 (à droite); remarquez l'absence de résidus de carburant dans le FCU du moteur numéro 2

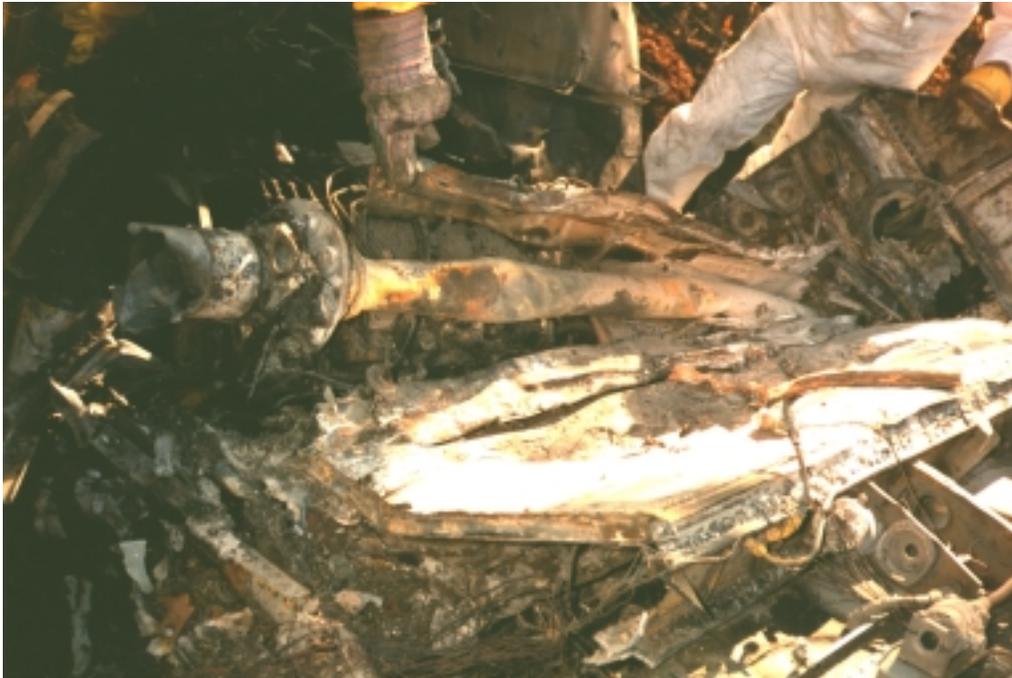
The sync shaft and corresponding stainless steel fire wall casing exhibited severe heat damage in the form of localised discoloration (Photo 39), particularly at the entry and exit points as the shaft passed through the seals. The seals were damaged by fire and would have allowed passage of soot, heat and other contaminants into the forward sync shaft tunnel. The damaged seals provide a direct access route between the heated and fire damaged engine area to the location where the soot was deposited on the inside of the sync shaft tunnel cover and which was removed by the first blade strike (see section 2.2.2). It should be noted that the fire in the #5 sync shaft area occurred where there is no ready fuel source; therefore, the fire or severe heat as a result of the fire must have migrated to this area. It is concluded that the open area of the sync shaft cover in the number two engine compartment allowed the fire to migrate to that area. To exacerbate this situation, the partial open nature of the cover may not allow the fire-extinguishing agent complete and direct access to this open area. This conclusion is supported by the heat damage forward of the engine compartment in the sync shaft area and the fact that witnesses observed smoke throughout the accident sequence. The investigation team has requested that the Technical Authority examine the effectiveness and coverage of the number two engine fire extinguishing system in the #5 sync shaft area.

Photo 39 - Engine Compartment (steel) Sync Shaft - Note discoloration due to heat (Number 1 engine door in foreground) // Compartiment moteur (acier) et arbre de synchronisation; remarquez la décoloration imputable à la chaleur (porte d'accès au moteur numéro 1 en avant-plan)

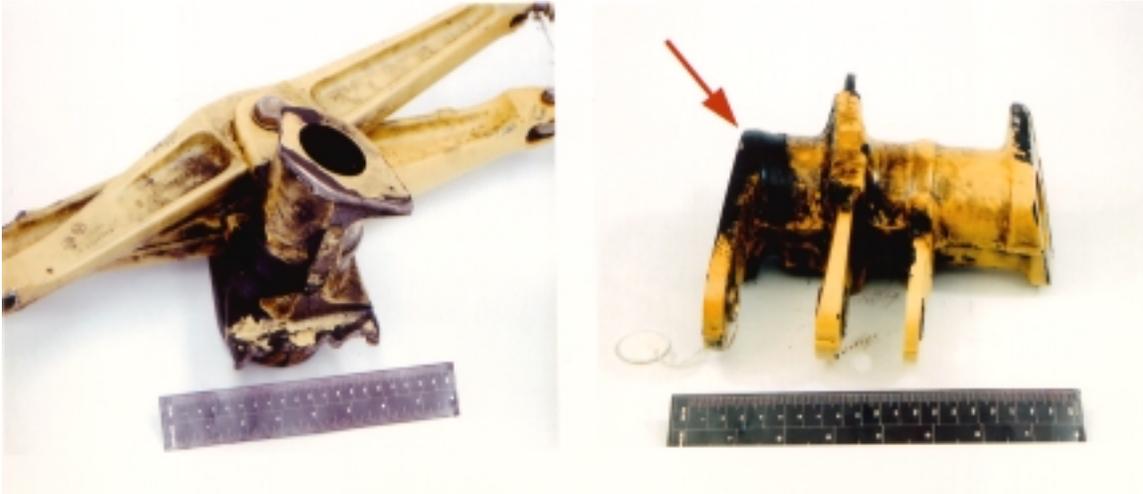
Photo 40/41 - Bell Crank Assembly - Note the signs of heating // Guignol; remarquez les dommages imputables à la chaleur

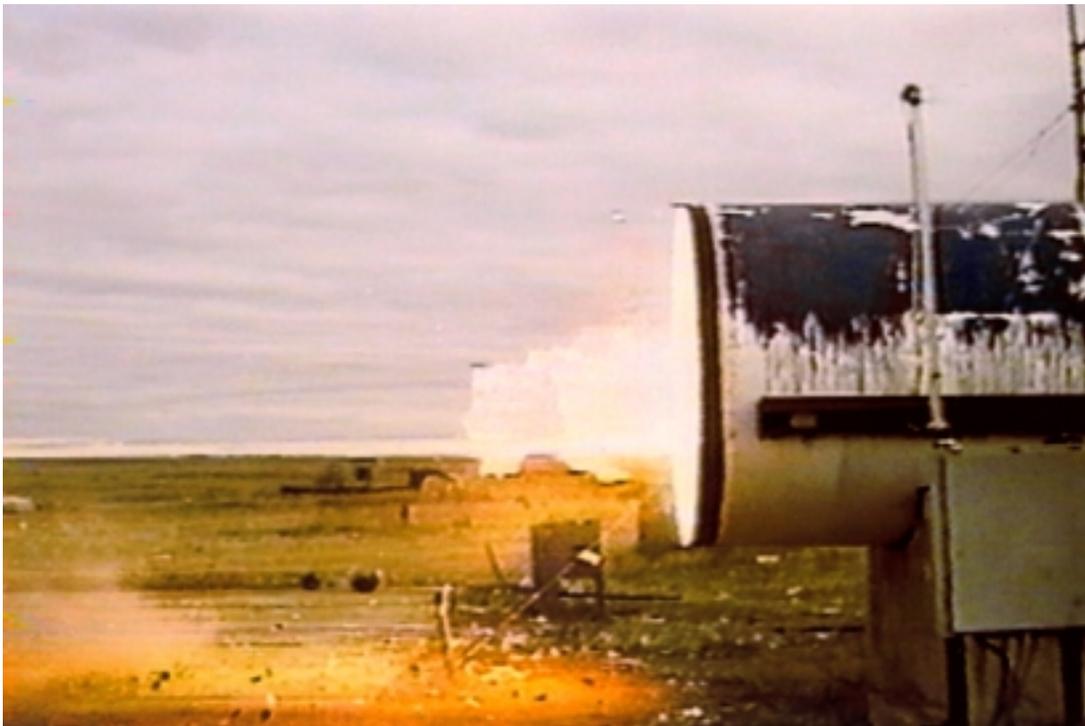
Photo 45 - DRES Engine Door Blast Experiment - Note flame emerge from structure (possible ignition source for fuels exterior of structure through vents) // Expérience du CRDS portant sur l'ouverture de la porte d'accès au moteur lors d'une explosion; remarquez la flamme qui sort de la structure (source d'allumage possible du carburant rejeté à l'extérieur de la structure par des mises à l'air libre)

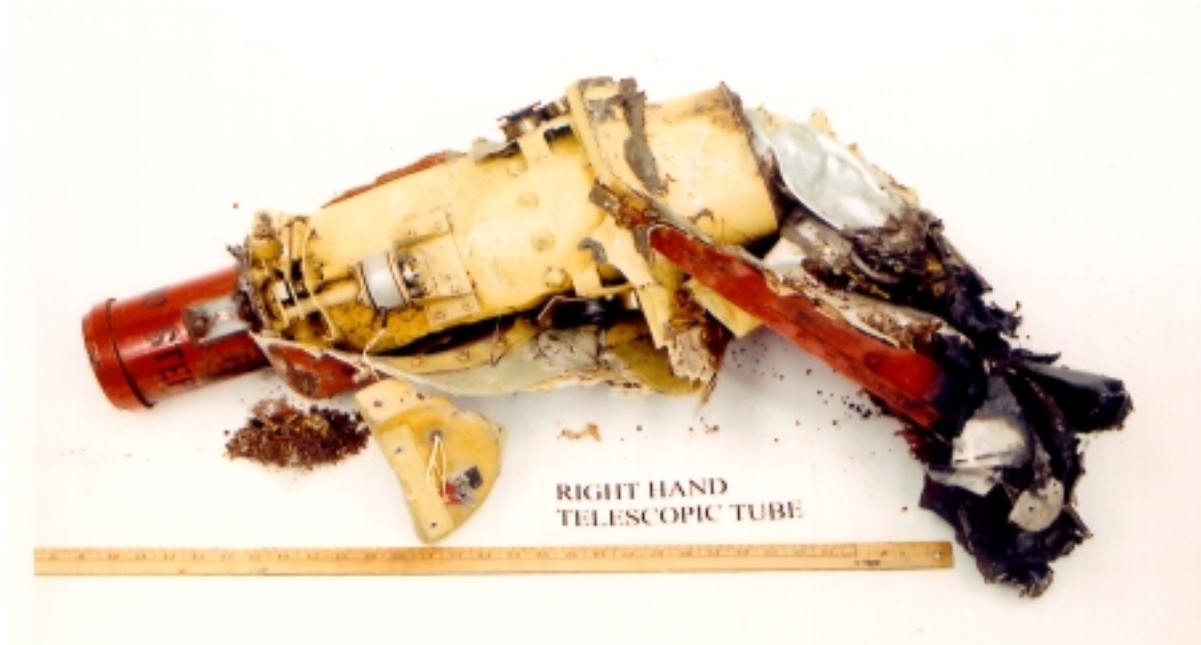
Photo 46 - Right Hand Fuel Dump Tube (retracted and confirmed)// Tube droit du vide-vite (rentré et confirmé)

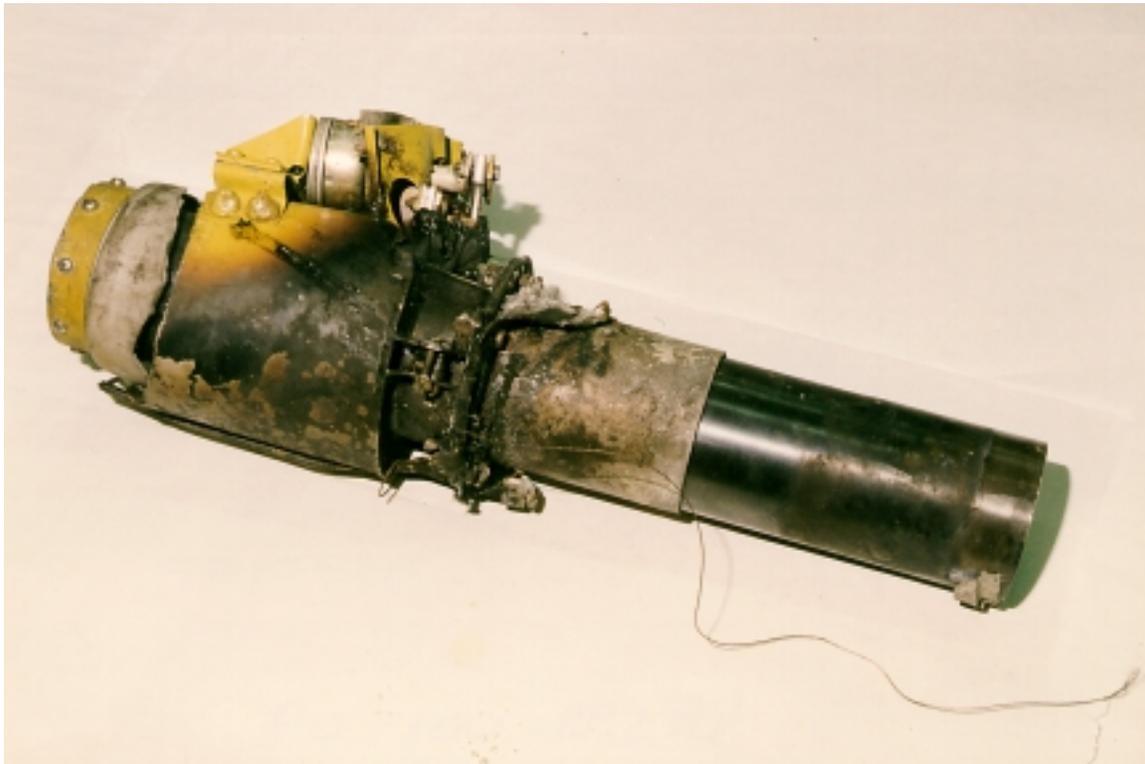
Photo 48 - Left Hand Dump Tube (extended and confirmed)// Tube gauche du vide-vite (sorti et confirmé)

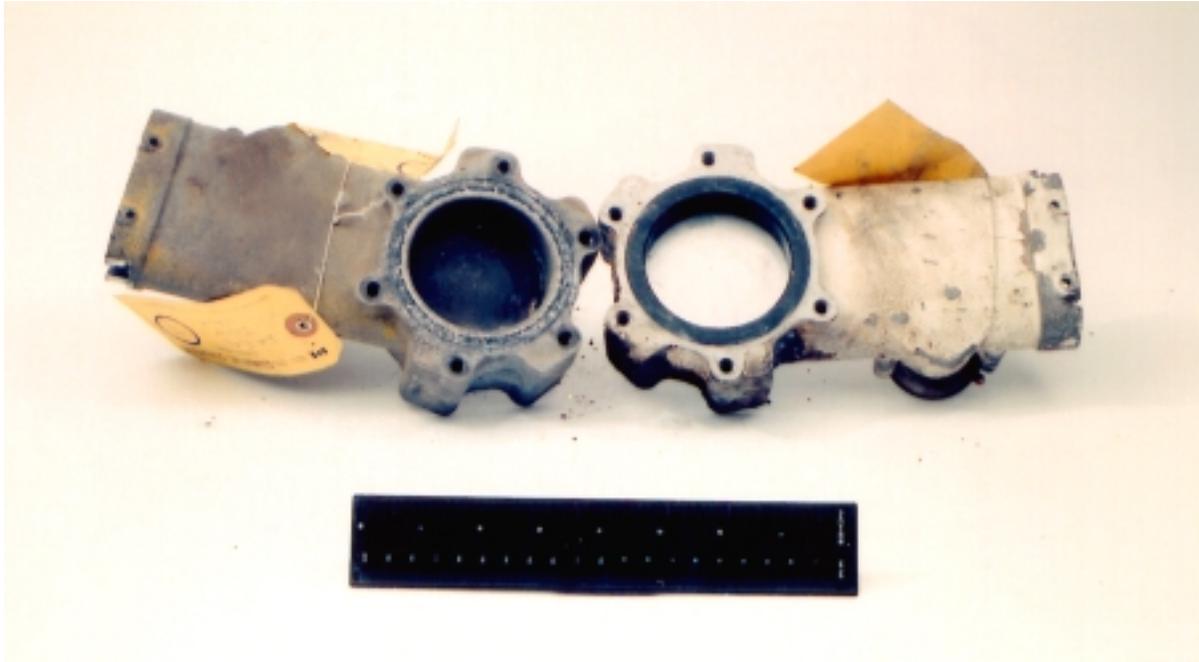
Photo 50 - Left and Right Fuel Dump valves (both in closed position)// Soupapes gauche et droite du vide-vite (toutes deux fermées)

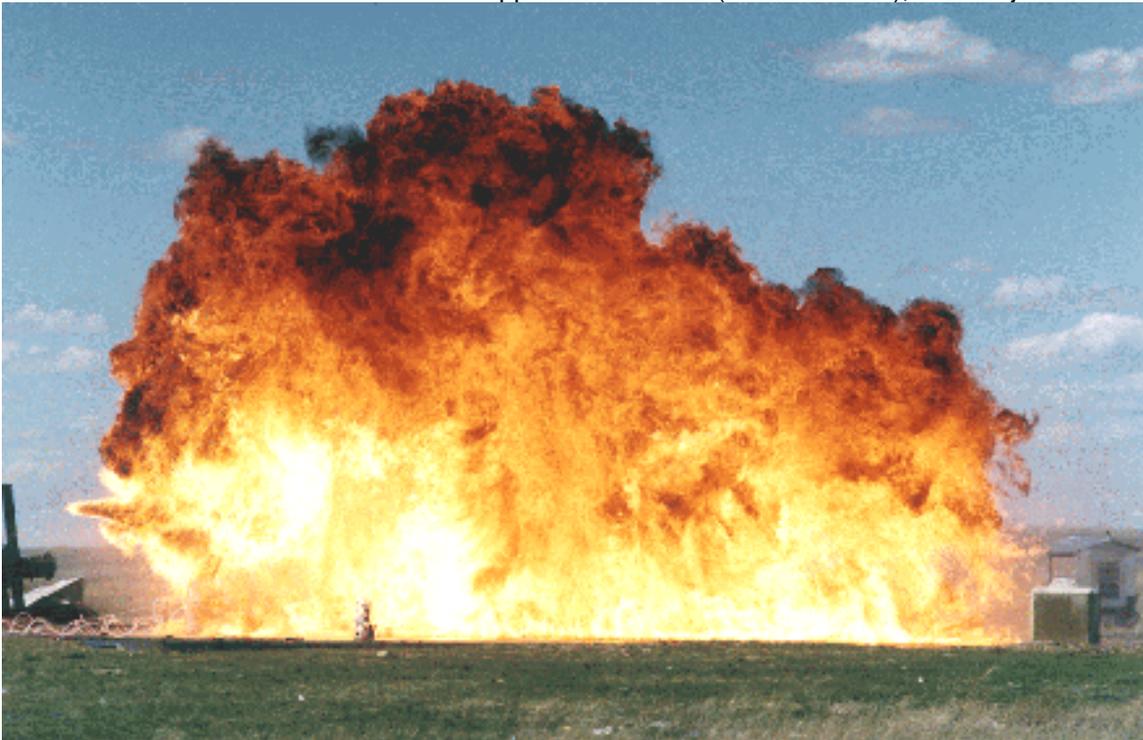
Photo 52 - DRES Experiment igniting simulated fuel dump cloud// – Expérience du CRDS visant à enflammer le nuage de carburant simulé à la suite d'un largage
