Aircraft Accident Summary
Résumé d'accident d'aéronef

TYPE: CH11305 Labrador

DATE: 02 October 98

**LOCATION: 3 NM South of
Marsoui QC.**

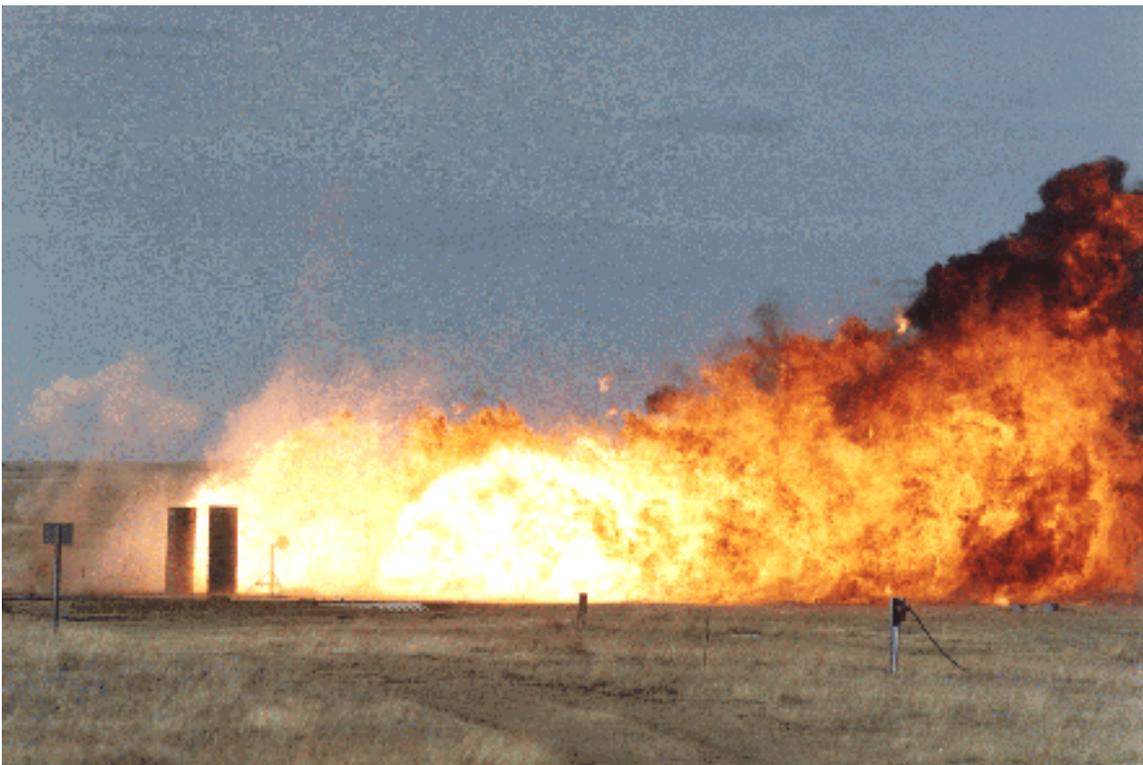
Photo 53 - DRES Experiment igniting simulated fuel dump cloud (under different conditions)// Expérience du CRDS visant à enflammer le nuage de carburant simulé à la suite d'un largage (dans des conditions différentes)

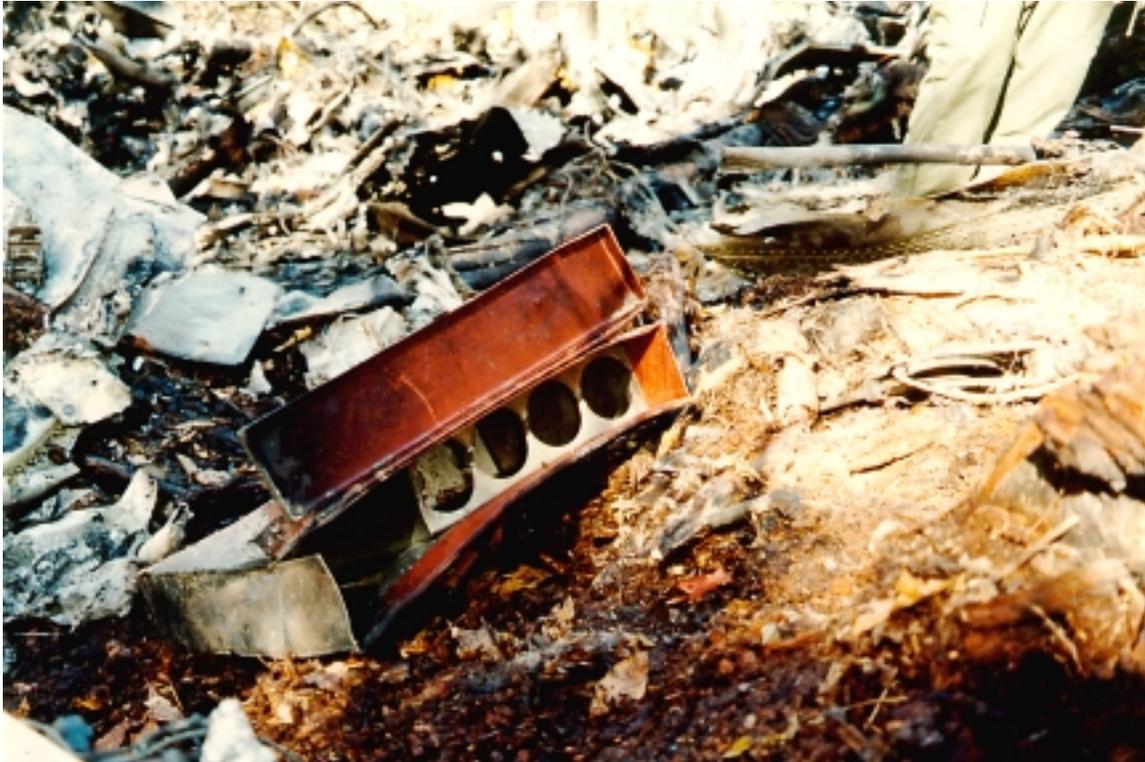
Photo 54 - Forward Ammunition Box// Boîte à munitions avant

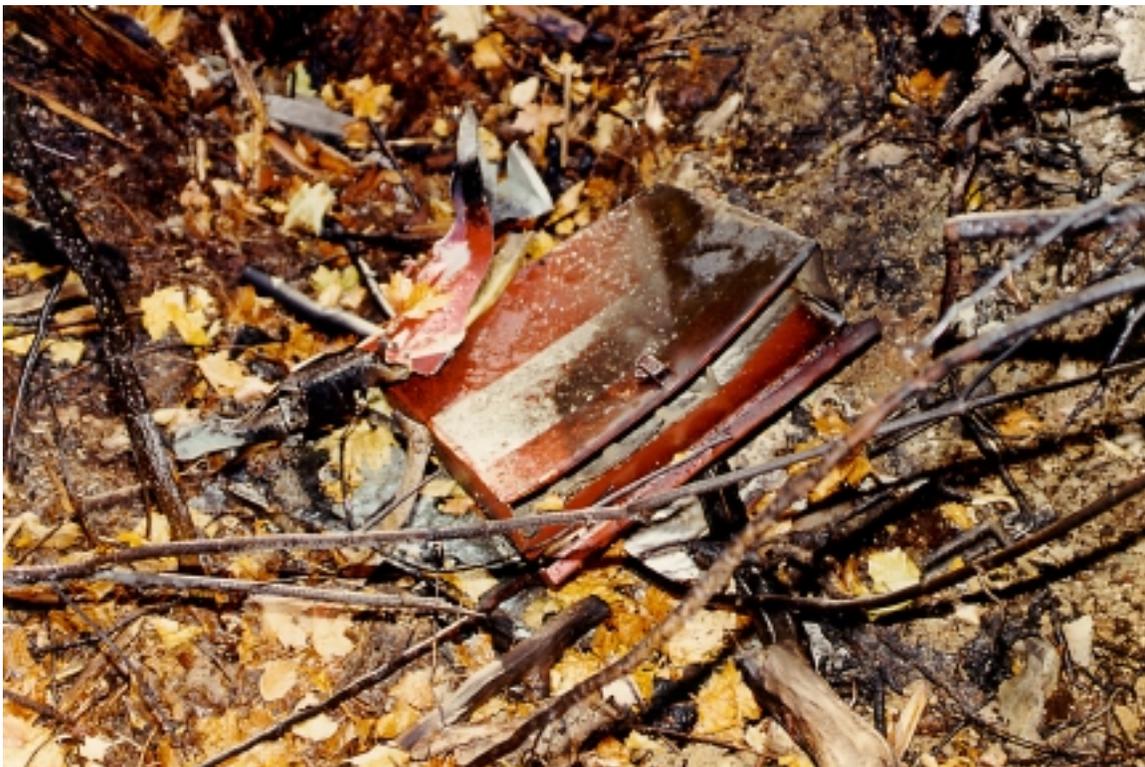
Photo 55 - Forward Ammunition Box (rear view)// Boîte à munitions (vue arrière)

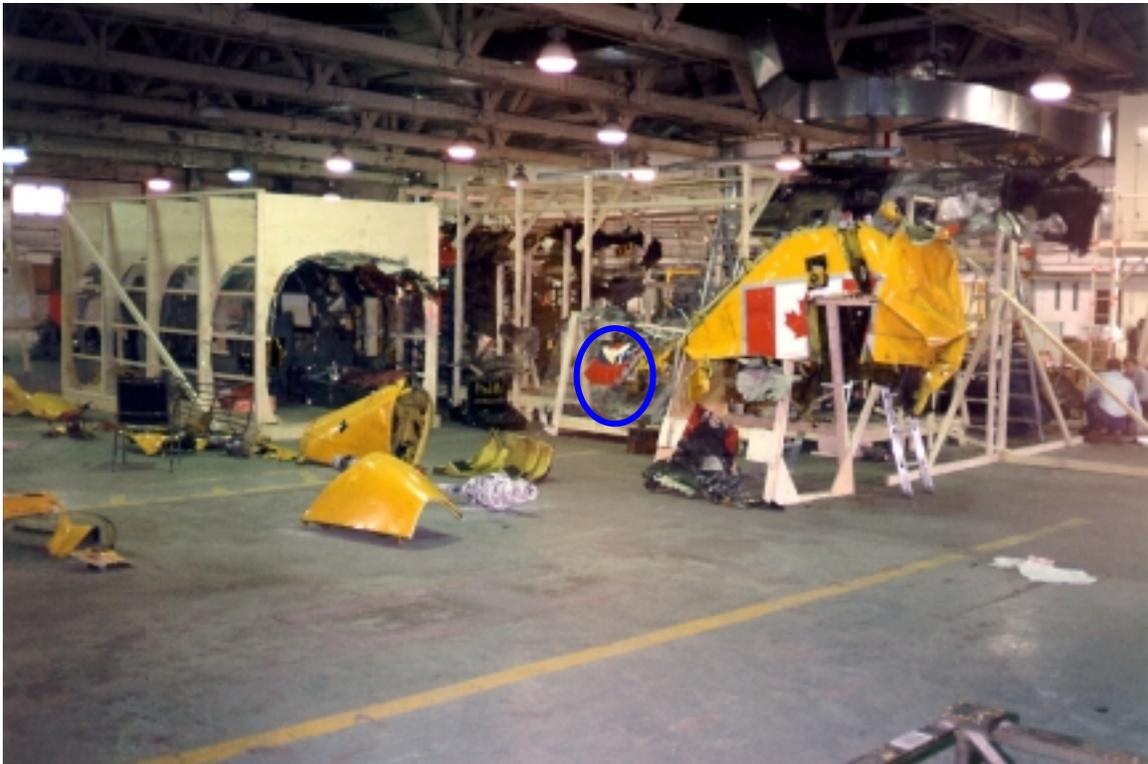
Photo 57 - Rebuild Facility showing Left Stub Wing Fuel Tank Section (circled)// Installation où l'on a procédé à la reconstitution et réservoir de carburant du moignon d'aile gauche (encerclé)

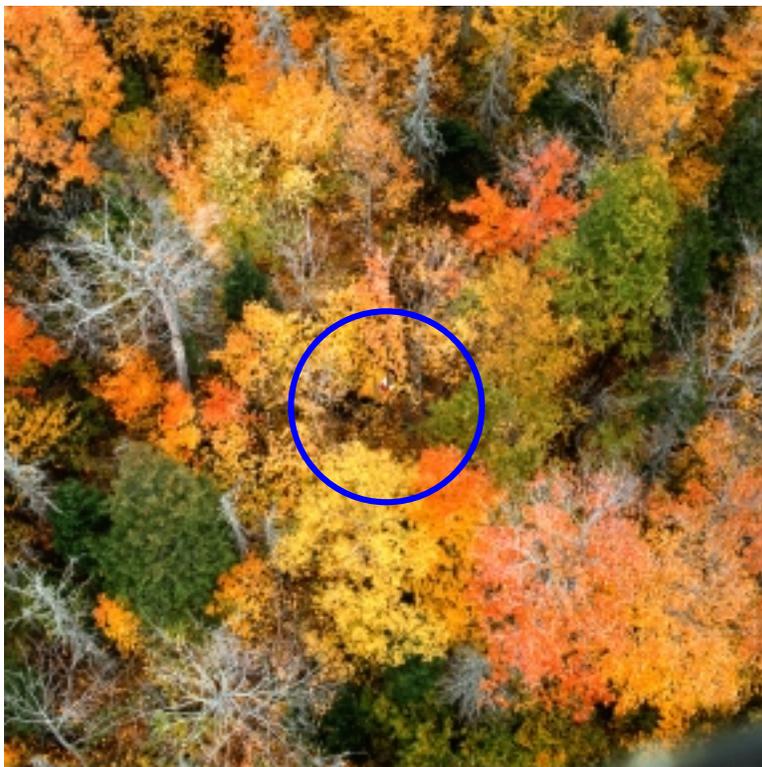
The aircraft broke into three main pieces: the forward fuselage, aft pylon and aft fuselage (Photos 1-4). The fuselage separated at flight station (FS) 220, just behind the spotter seat positions and the aft pylon separated at waterline 71, just below the Canada flag. The three sections fell separately at near vertical angles. The post crash fire extensively damaged the aft fuselage (Photo 5). The aft pylon section showed minimal rotational damage to either the rotor blades or aft pylon shaft (Photo 6). The rear red blade sustained extensive burn damage (Photo 7), the rear yellow blade sustained some fire damage, the remaining aft blade (green) showed no heat damage but did have soot deposits. The aft pylon sustained heat damage in the vicinity of the Auxiliary Power Unit (APU) and the utility hydraulic reservoir. The forward fuselage sustained massive structural

Photo 2 - Site 2 Rear Pylon (circled)// Secteur 2 : pylône arrière (encerclé)

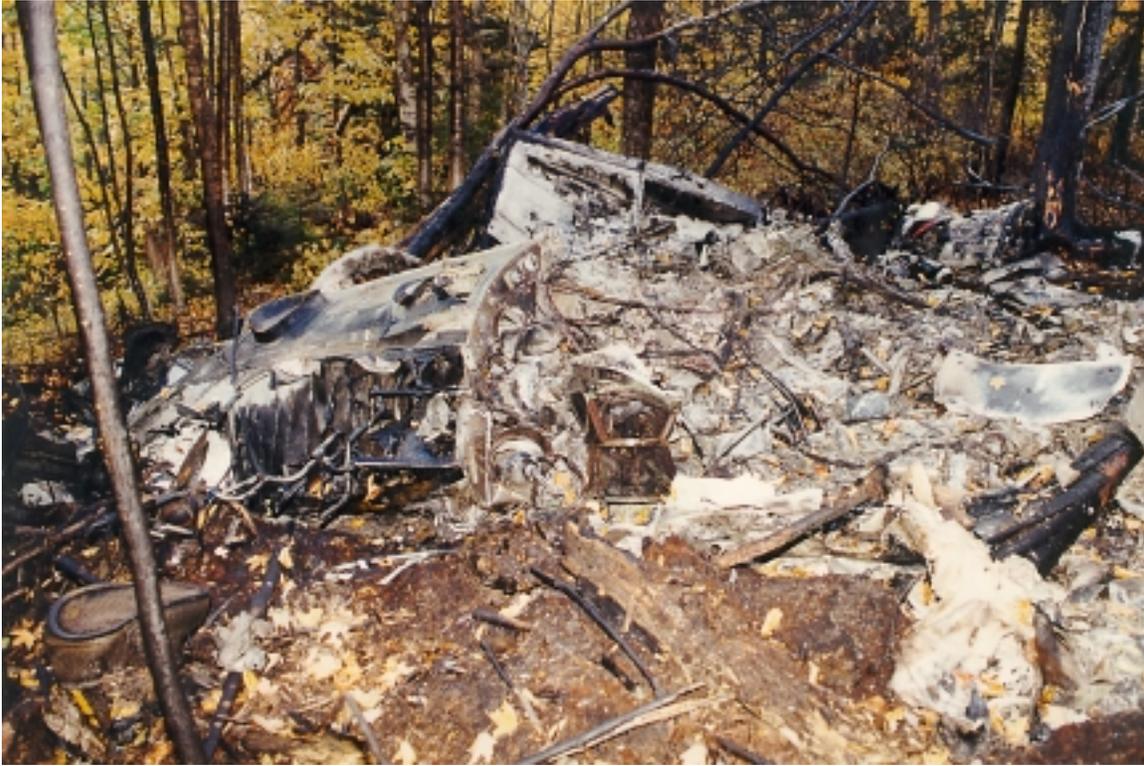
The forward fuselage and aft pylon sections did not burn on the ground. The aft fuselage section includes the fuel tanks, engines and aft transmission. This section caught fire which severely damaged most of this wreckage and much of the surrounding forest. The aft transmission casing was ignited and was reduced to ash by the intense magnesium fire (Photo 17). Local witnesses alerted the Sûreté du Québec in Ste-Anne-des-Monts at 1851Z. Local volunteer fire-fighters were on the scene within 20 minutes. Due to the steep terrain they could only get hand held extinguishing equipment on site. By 1945Z the fire-fighters had contained the blaze by trenching around the impact area. The aircraft's remains smouldered for the next three days.

Photo 5 - Site 3 - Aft Fuselage, Engines and MGB// Secteur 3 : fuselage arrière, moteurs et boîte de transmission principale

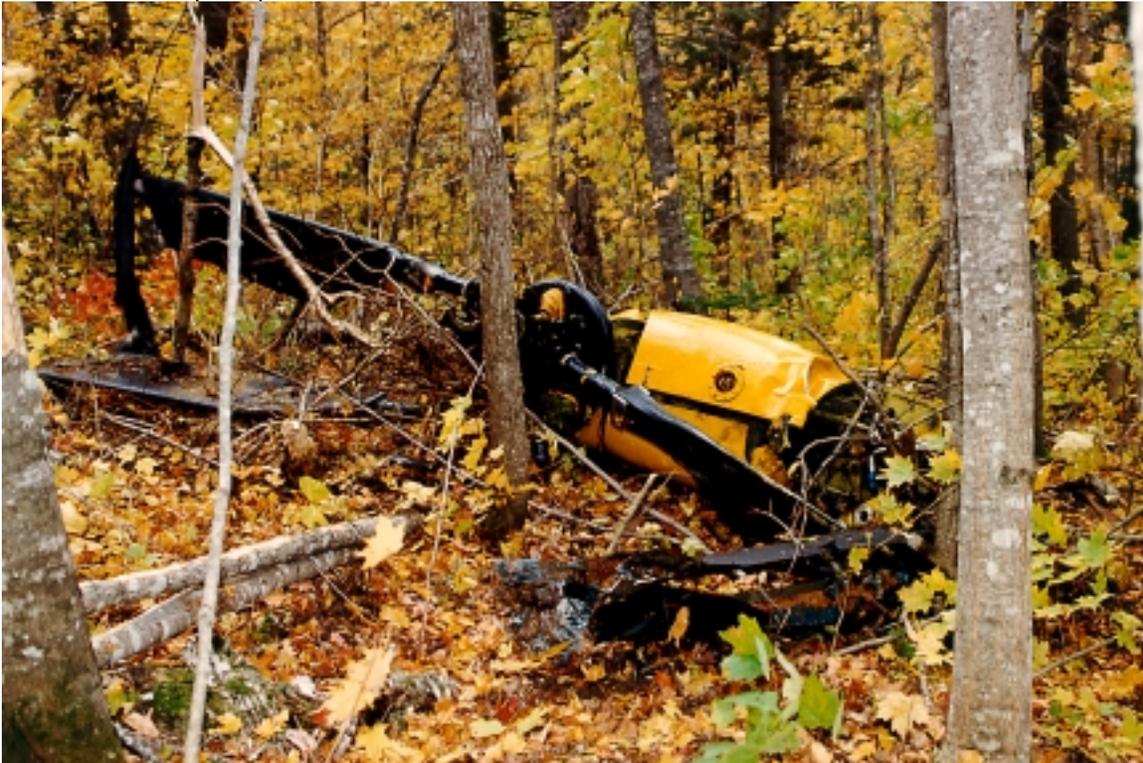
Photo 6 - Site 2 Rear Pylon and Rear Rotor blades (note undamaged surrounding trees)// Secteur 2 : pylône arrière et pales du rotor arrière (remarquez les arbres intacts)

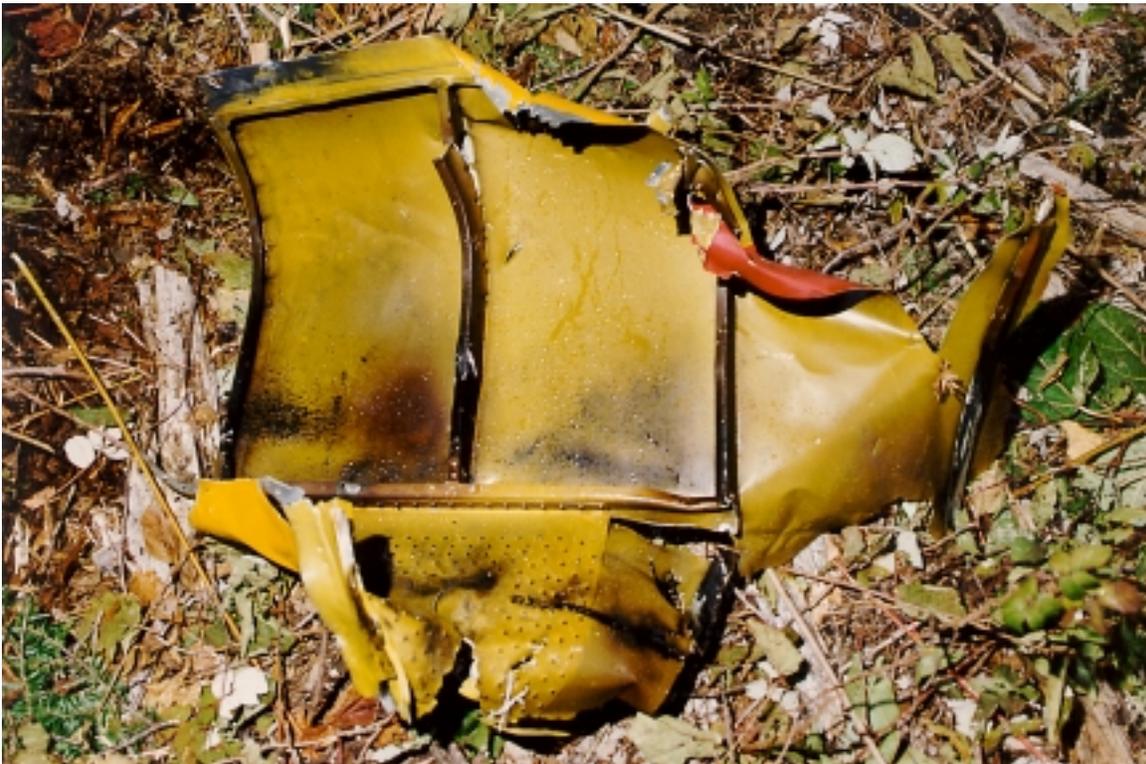
Photo 12 - Debris in Upper Field - Tunnel Cover Removed during first blade to fuselage strike (note soot on inside right)// Débris récupérés dans le secteur supérieur : carter du tunnel arraché lors du premier contact entre les pales et le fuselage (remarquez la suie sur le côté droit de la surface intérieure)

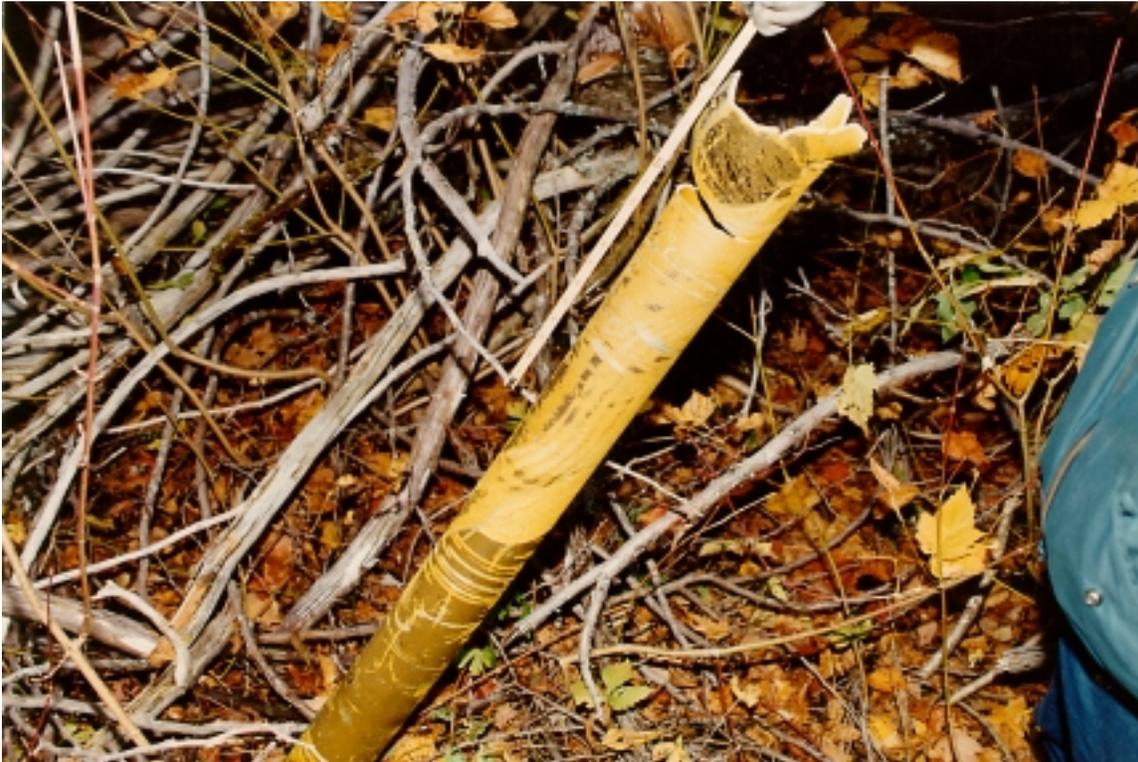
Photo 13 - Sync Shaft Fragment - Upper Debris field//– Morceau de l'arbre de synchronisation récupéré dans le secteur supérieur

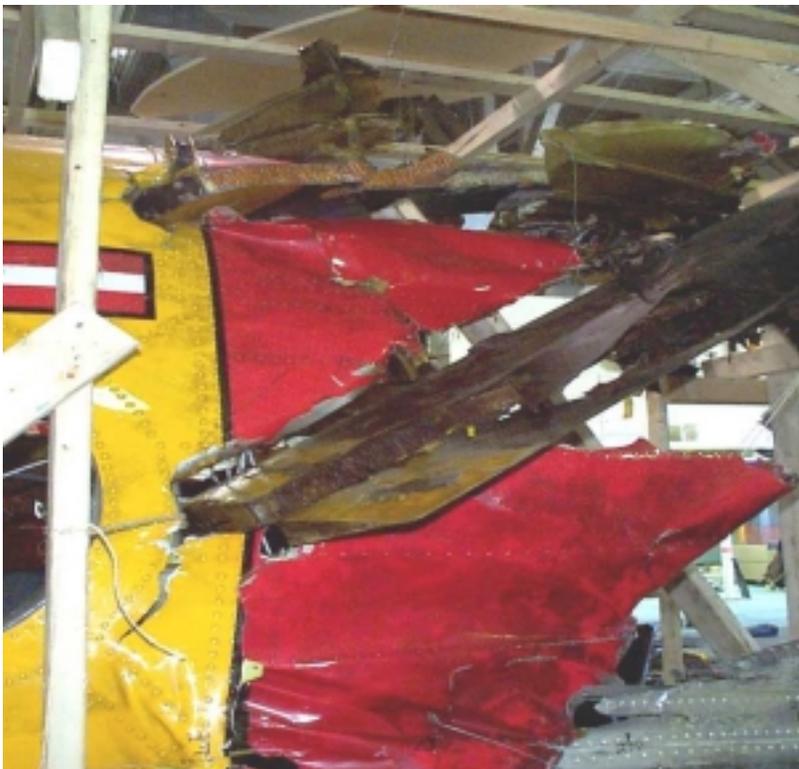
There were marks from four rotor blade strikes on the side fuselage of the aircraft, starting at the upper tunnel area and extending down to the floor in the area of the left spotter's seat (Photo 15). Corresponding marks on the rear rotor blades showed all four cuts into the fuselage had been made by two of the three rear rotor blades (Photo 16).

The marks, scratches and indents on the blades were examined with direct reference to the fuselage punctures. This revealed that only two of the three rear rotor blades made all four of the fuselage cuts. The two conspicuous sequential blade punctures on the side of the aircraft (photos 15 & 16) are the correct relative length for a complete blade and the right distance, on an intact aircraft, from the rear rotor hub. Further, the blade that did not enter the aircraft was found intact. This is clear evidence that there was no failure of the rear blade structures before the blade to fuselage contact. Also, the "first strike" tunnel cover was at the start of the debris field and it was collocated with small pieces of blade material. This combination of facts indicates that the blade to fuselage contact was the mechanical mechanism that precipitated the in-flight break up.

Photo 16 - Blade Pieces Inserted in Fuselage (confirming only 2 blades made all 4 cuts in fuselage).// Morceaux de pales enfoncés dans le fuselage (confirmant que les quatre entailles dans le fuselage sont attribuables à deux pales).

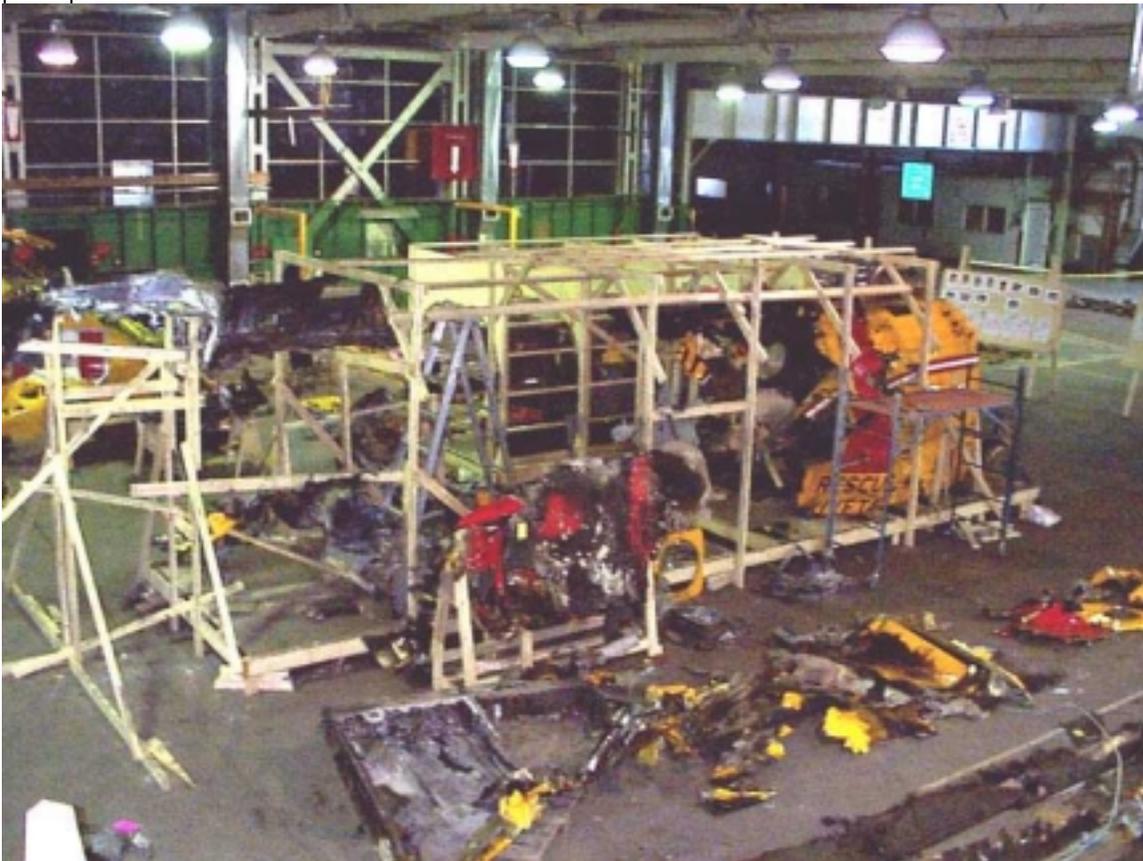
With the wreckage in Ottawa, structural jigs were constructed to facilitate the three-dimensional re-build of the aircraft (Photo 18). Also, the debris was laid out in its relative location before the break-up so that damage patterns could be examined and the break-up sequence determined (Photo 19). This approach allowed direct correlation and comparison of damage sustained to the various aircraft components in the accident. This process revealed that the areas of greatest concern were located in the rear of the aircraft, thus the re-construction concentrated aft of Flight Station (FS) 160 (just aft of the forward entry hatch). All aircraft components recovered to the rebuild site were examined for relevance to the accident but, for the most part, only the components in the cockpit and aft of FS 160 contributed to an understanding of the events.

Photo 18 - Rebuild of Ch11305 - Right side// Reconstitution du CH11305 : côté droit

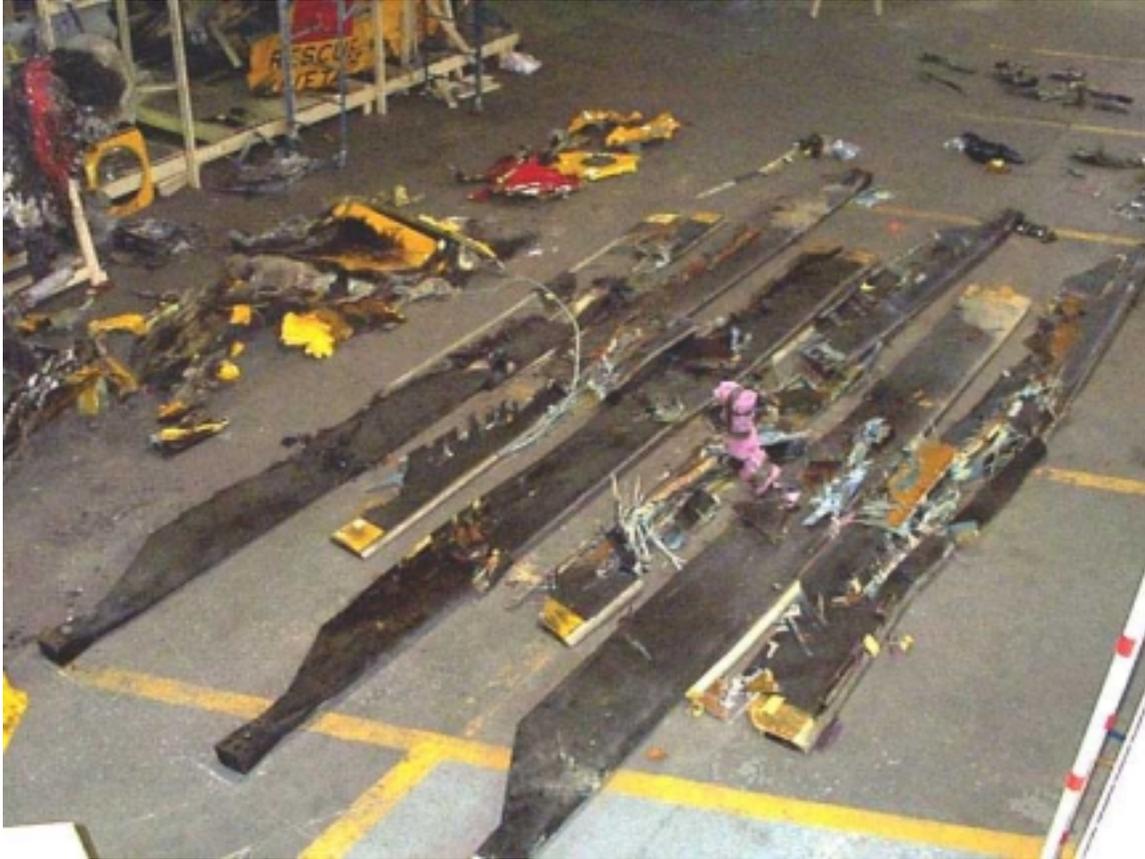
Photo 19 - Rebuild of Rotor Blades// Reconstitution des pales de rotor

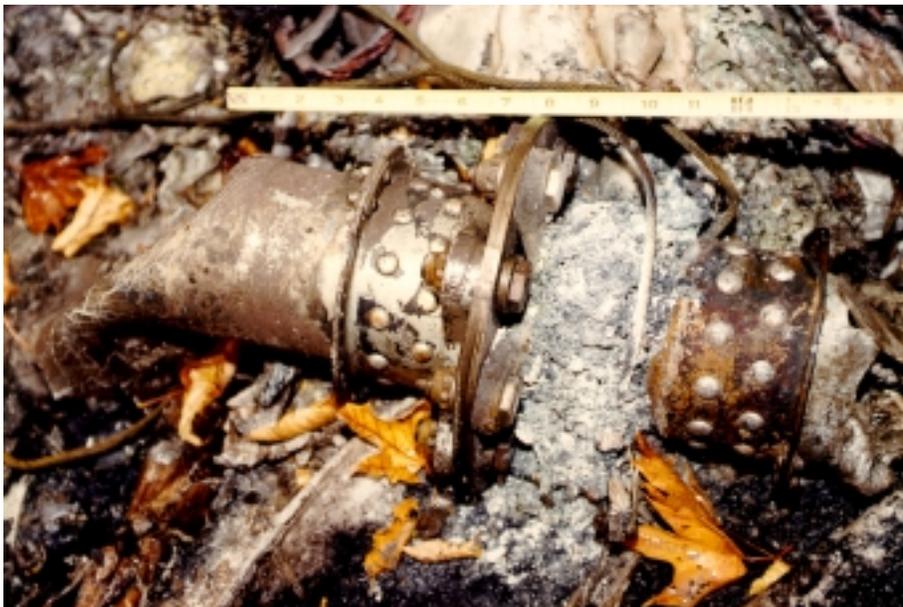
still attached (Photo 29). This damage pattern suggested these sections of the sync shaft were melted in the post crash fire.

Photo 29 - Thomas Coupling and melted Sync shaft sections// Raccordement de Thomas et sections fondues de l'arbre de synchronisation.
